Importance of drill string assembly swivel in horizontal drilling

A part of the drill string – the swivel (rotational connector) – accomplishes an important task in the horizontal drilling. Its malfunctioning makes it impossible to draw in (install) large diameter and length pipelines. The causes of the connector break-down during the horizontal drilling are investigated in the paper. The drilling has been made for twenty inches gas pipeline installation during reaming operations. A trouble was encountered making good work conditions of a system consisting of the drilling machine drill string reamer swivel tube shield of Cardan joint and the gas pipeline 500 m long. In this case, the swivel brokes down and the planned operation was not finished. The assessment of improper drilling conditions, selection of operation system components, and drilling parameters and the insufficient technological supervising have created an excessive risk of failure. A proper application of technical analysis would considerably decrease the hazard of failure which cause large costs, delays and decrease of confidence to the drilling contractor and pipeline installation.

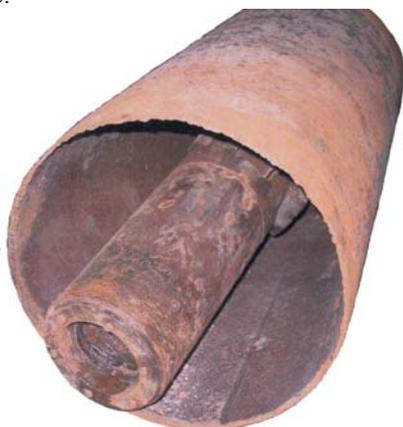
Fig. 2. A swivel in the protective pipe of leading head of the gas pipeline

The location of a swivel in the protection of conductor head of a gas pipeline with the visible Cardan joint pin is presented in Fig. 2. A crack of the shaft is visible in the front part of the swivel. The leading head with the partly cut off casing and the intermediate connector, presented in Fig. 3, is ribbed on the gas pipeline side.

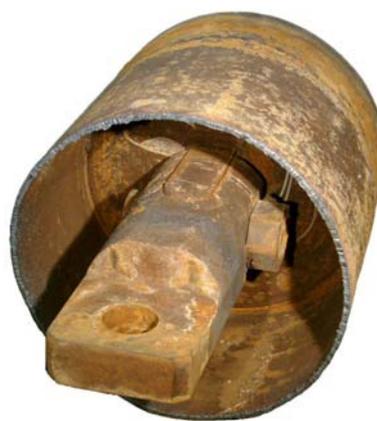
Fig. 3. Leading head and intermediate connector.

A considerable frictional wear of the inner casing pipe head was observed at about 1/3 of circumference in the front part, overlapping with the reamer inside casing along a section ca. 30 cm long. Moreover, the casing pipe was deformed in the sections of increased curvature after the reamer-head set was installed. An oval was formed of 480 mm/510 mm. The cut swivel with destroyed bearing elements, severed shaft, sealings and grease are presented in Fig. 4. The 92 mm diameter main shaft in the back part had bearing in the immobile roller body of external diameter with an angular bearing (double purpose bearing). The back nut of the bearing of external diameter was fixed in a position with a plate screwed to a flat back surface of the nut touching the relevant protrusion on the shaft.

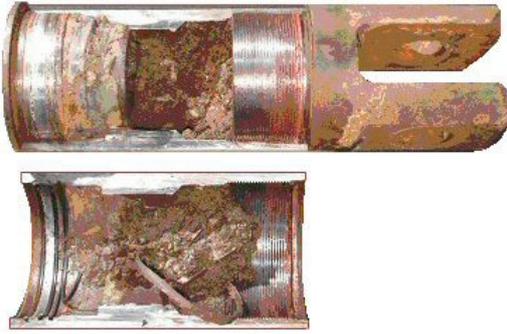
Fig. 4. Cut swivel with destroyed bearing elements, severed shaft, sealings and grease. Fig. 5. Internal elements of the damaged swivel.

Cutting the tractive swivel revealed a considerable damaging of the swivel's elements, particularly the bearings. The elements of the bearing got stuck most probably because of the huge load in the angular bearing system. This, in turn, was caused by blocking of one of its elements because of excessive abrasive wear or cracking. The bearing blockage was accompanied by a drastically increased friction, cracking of the inner race of the bearing (Fig. 7).

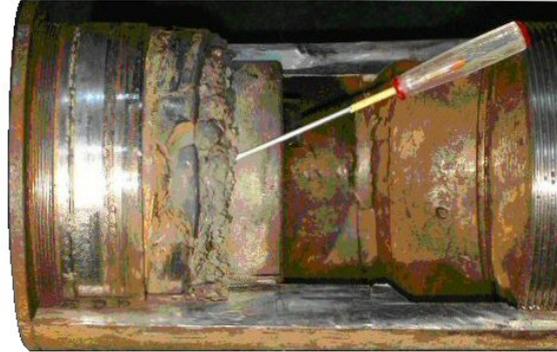
The second angular bearing was in the front of the main bearing, separated with a distance protrusion of decreased inner diameter in the body (Fig. 5). A roller bearing was disposed before the oblique bearing,

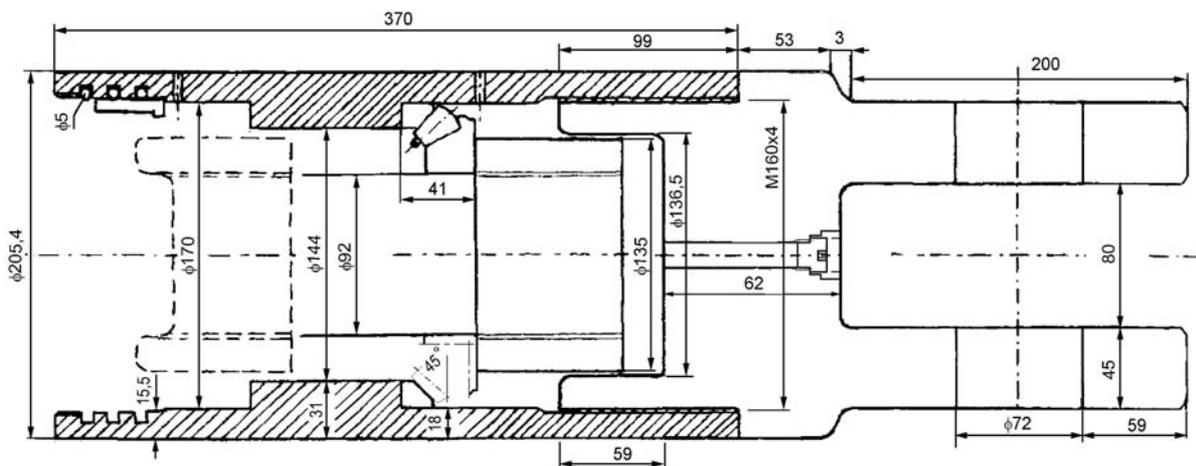
Fig. 6. Design of a swivel – based on the measurements of damaged elements of the swivel

The location of the shaft at the moment of its final failure was denoted with a dashed line. The angular roller bearing $<45^\circ$ (22 barrels) disposed in the back part of the body of the swivel of 170 mm of external diameter and ~ 92 mm of inner diameter was supposed to transmit the whole longitudinal force during the gas pipeline tripping operation. The round nut of 135 mm in diameter was touching the inner race of the bearing with its flat surface.

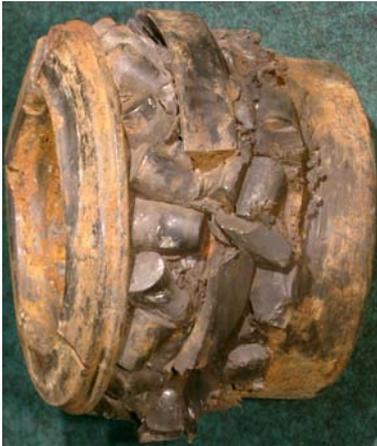
Fig. 7. Elements of bearings fixed at the end of the shaft.

This also resulted in a damaged bearing cage, cutting of the barrels and finally dragging of these elements through a contraction in the body of the swivel and disposing them against the elements of the auxiliary bearing.

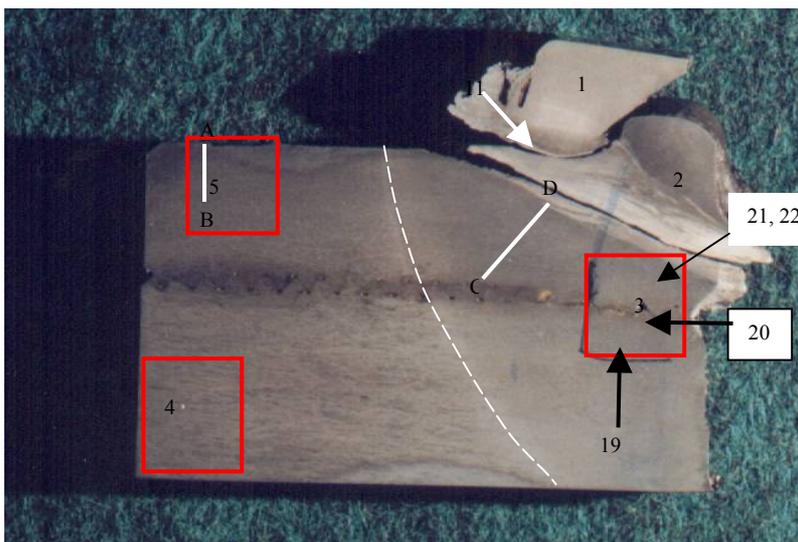
Owing to the increasing friction and emission of heat, the contacting surfaces started to blur, the steel became softer, then it melted in the zones of highest loads. The strength of the material of the tractive shaft lowered in the vicinity of the melting zone. Cracked inner races of both bearings, plastic deformations of barrel, many of which are stuck in the melted bearing material, are presented in Fig. 7. Owing to the considerable lowered strength, the shaft was twisted and severed. The color and consistency (density and viscosity) of the semi-solid lubricant from the back part of the swivel had a regular form, although was strongly contaminated with friction products, abrasive wear of the bearing elements and to a small degree with sand. The quantity of grease in the back part of the swivel (as compared to the front bearing) was 0.55 l making up ca. 80 % of free space in this part of the swivel. A plate was cut off the melted end of the shaft and bearing (Fig. 7) for metallographic specimen analyses. A polished surface of the sample plate with visible zones of thermal impact is presented in Fig. 8. This material underwent a high temperature in the course of friction processes in the stuck bearing. The metallographic analyses were performed on a section of the bearing and the shaft which got melted and welded during the break down. From this section, samples (No. 1, 2, 3, 4, 5) were collected for microscopic analyses. Lines, along which the hardness tests were carried out with a Vickers hardness tester at 300 N are also marked in the figure.

Fig. 8. Section of the shaft, barrel, bearing race and the fastening nut from the damaged area with indicated places where the samples were collected for the microscopic analyses (1, 2, 3, 4, 5). A-B and C-D – lines along which hardness tests were made.

Moreover, the boundary of influence of heat over 700 °C was marked with a dashed line. The race was made of bearing steel having a martensitic structure with divorced cementite. In the zone of welding the materials mix up (Fig. 9). Except for the zone of heat impact, the barrels have a martensite structure with a cementite separation, typical of bearing steel. Judging from the structural character, the nut is made of a similar material as the shaft. The temperature of nut reached over 750°C in the zone of heating. This can be proved by the presence of a structure of martensite bainite and retained austenite (Przybyłowicz 1999). The material of the shaft beyond the heat impact has a bainite-ferritic structure of hardness of about 250 HV. In the heat affected zone (sample 3) the hardness is slightly higher 260–270 HV. The measurements of hardness in the heat affected zone up of the nut from point C to D revealed an increase of hardness 240 to 312 HV, which is justified by the formation of martensitic structures. The nut underwent strong friction forces against the cooperating elements (Fig. 10), resulting in visible deformations of the surface.

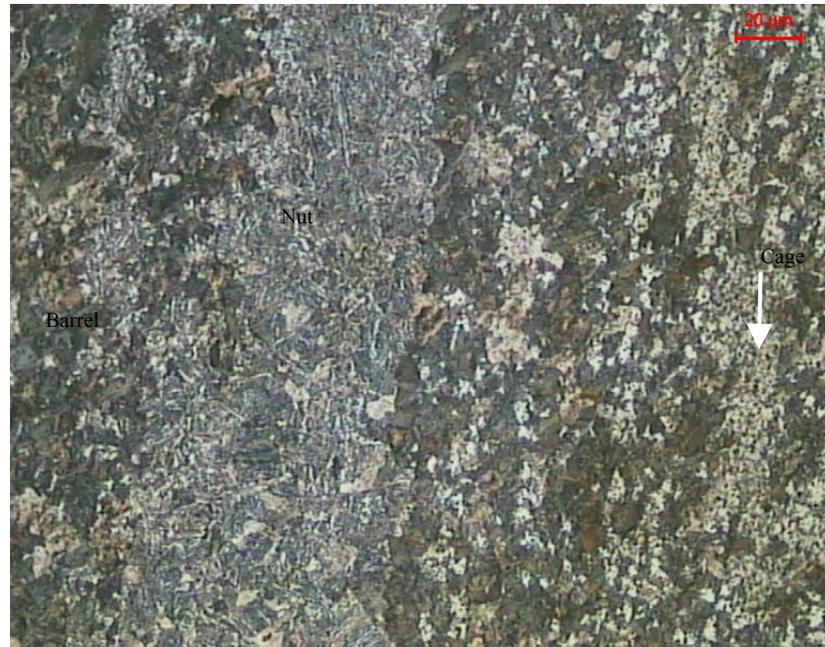
Fig. 9. Structure of the zone of welding of bearing cage, nut and barrel. Visibly mixed materials. Sample no. 2.

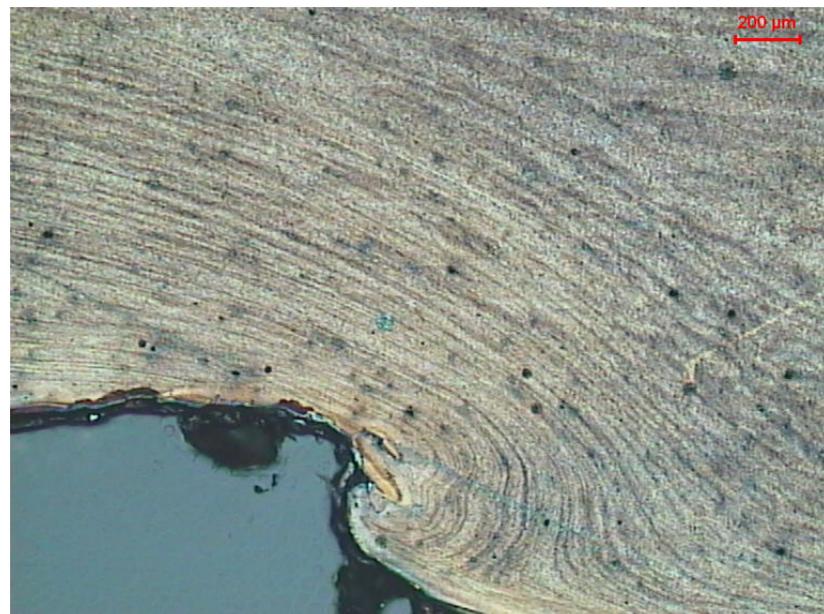
Fig. 10. Strongly deformed surface of the nut. Sample no. 5.
