Dangerous Planar Rockfall in an Open Pit: A Case Study from Host'ovce Quarry, Slovakia

Jaroslav BUŠA^{1*}, Julián KONDELA², Roman FARKAŠOVSKÝ³ and Stanislav JACKO⁴

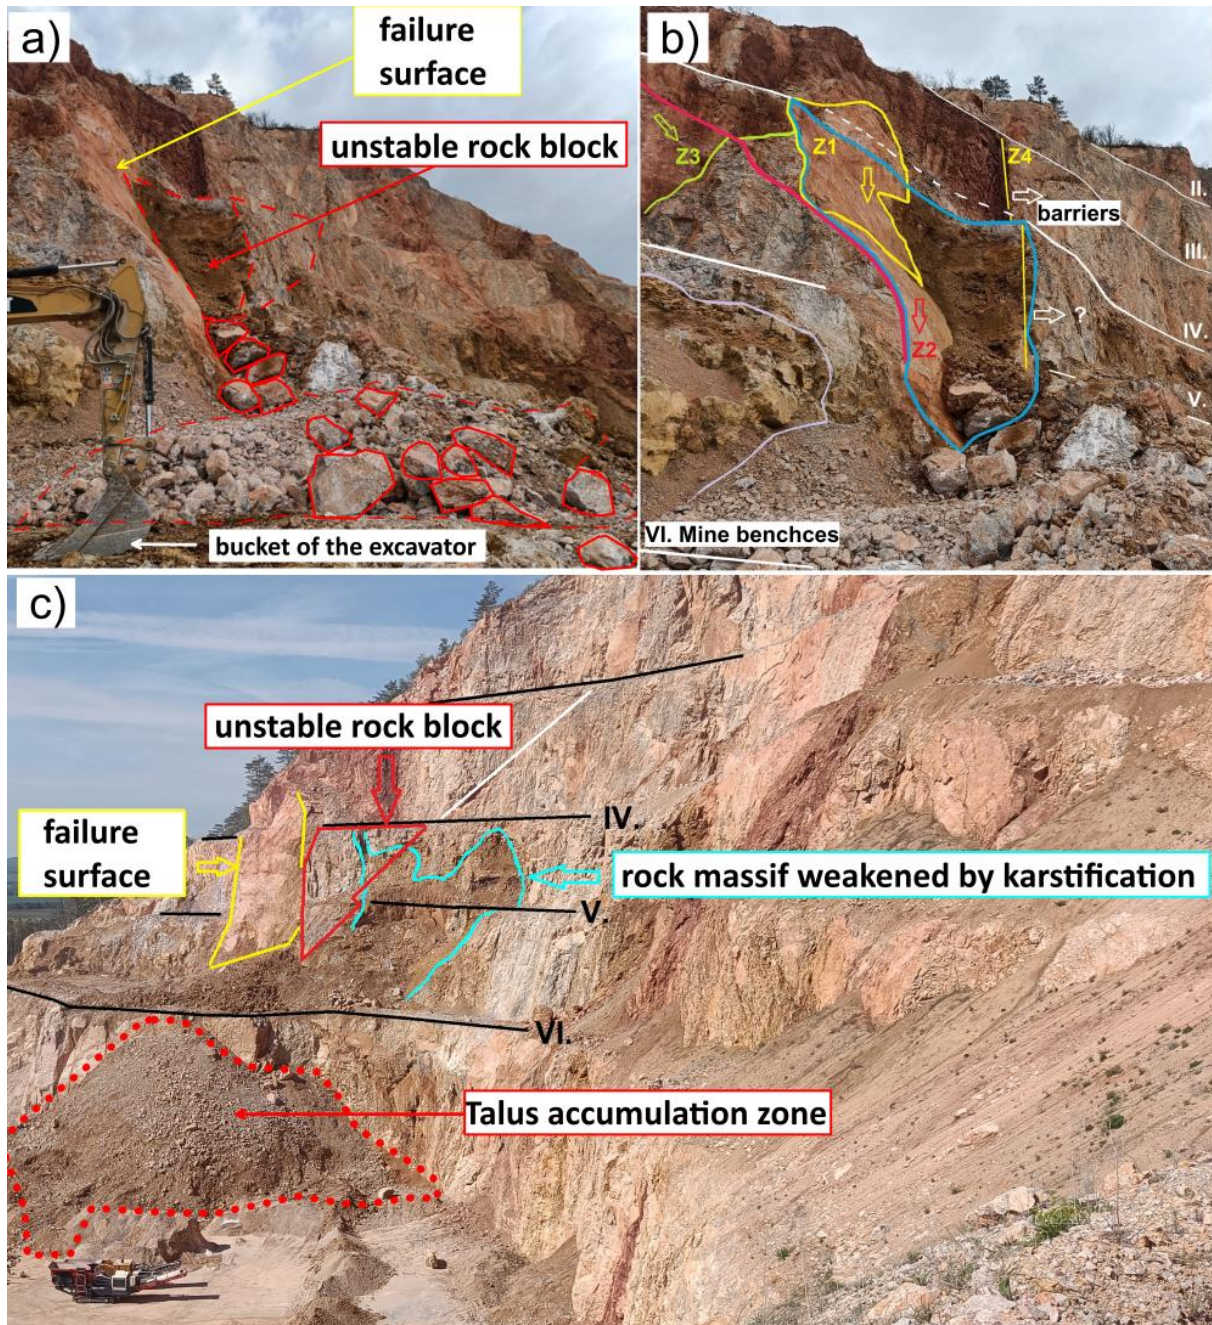
The geological structure within the mine is highly complex and directly affects the stability of the pit walls. The first signs of instability on the 4th and 5th mine benches appeared in March 2023, when a rockfall was triggered. The shear zone and the accumulated material from this initial event are shown in Figure 4a and in Figure 5 (Locations No. 6 and No. 4).

In cases where fault surfaces are part of karst cavities or border them, they are usually smoothed (corroded), often covered with sinter coatings of varying thickness, sometimes with karst decorations. These areas may also represent the edges of karst cavities, which may be filled with sandy-loamy-clayey poorly consolidated sediment, or even solid sedimentary rock. The solid sedimentary rocks in the cavities are characterized by obliquely deposited layers of sandstone and siltstone. Their oblique orientation is the result of tectonic movements along the aforementioned fault structures. The cavities also contain disordered material of boulder-sized breccias cemented by unconsolidated clayey fill. Over time, after the formation of structures with this type of fill, the influence of climate or mining (technical seismicity) causes the boulders to become loose from the fill. They fall spontaneously and descend to lower platforms by landslide or collapse, and temporarily stop. Alternatively, they may collapse onto the lowest VI mine benches (Fig. 4a).

Fig.4. Documentation after the rockfall between mining floors III and VI of the quarry. Debris and rubble cone from the rock collapse from the III. and IV. Mine benches with the position of boulders captured on the lower V. mine bench. (a) Schematic of the succession of tectonic fault structures (fault planes – youngest red – Z2, older yellow – Z1, Z4 and oldest green – Z3) and karst phenomena (breccia and karst zone – blue), which, due to their spatial position and mutual interaction in the rock massif, caused the collapse of rocks. (b) The orientation of the quarry wall, which is almost parallel (in direction and inclination) to the tectonic structures (red, yellow) bordering the karst zone with karst fillings, significantly contributed to this. A significant factor in reducing the stability of the massif was also the excavation at the IV. and V. mining levels, which undercut and exposed the zone of breccias and intensive karstification. State after the rock collapse and the delineation of the unstable rock block (red) in the massif. This is a block in the massif, tectonically bounded, with partial representation of karstified rocks (blue). (c) A view from the accessible part of the quarry to the inaccessible part of the quarry after the rock fall.

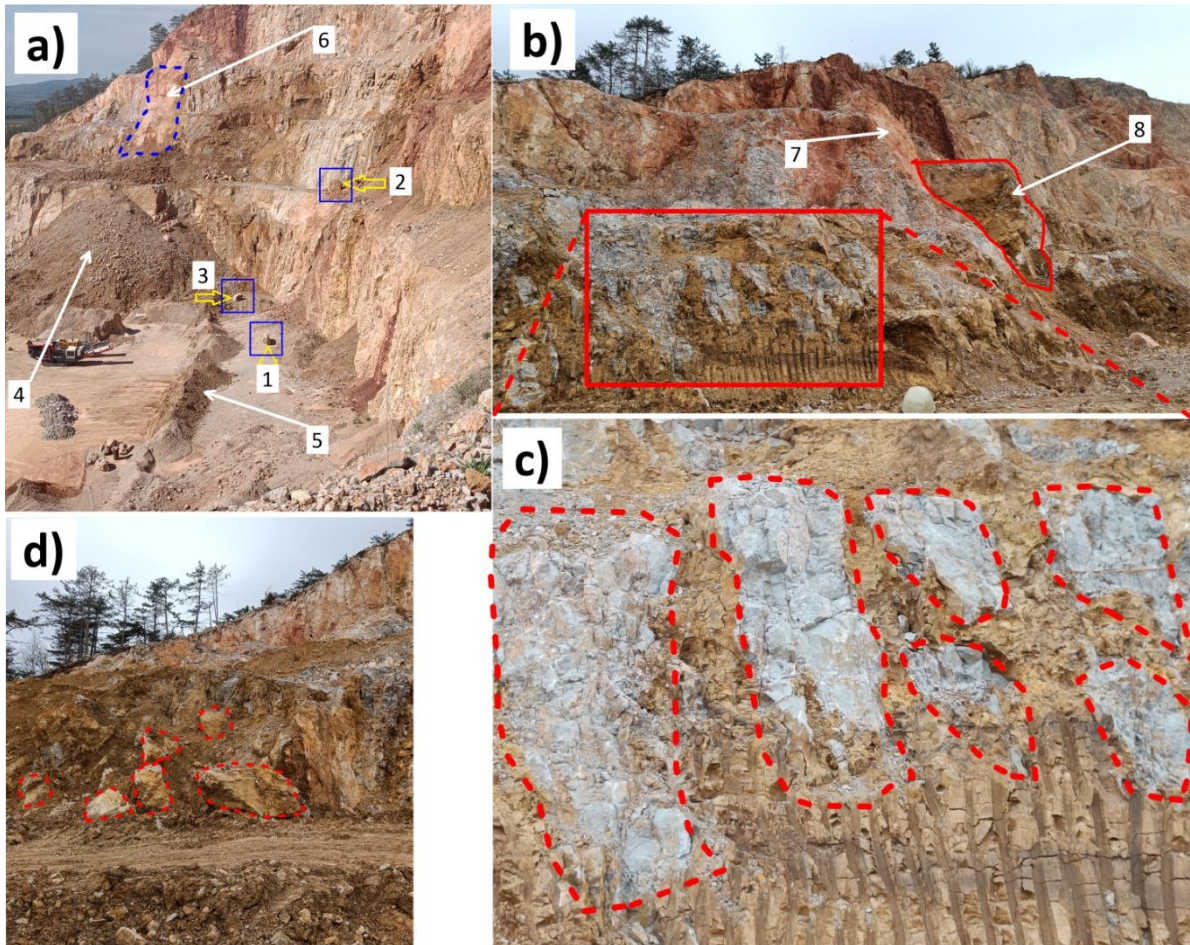
The rockfall from the pit walls is in another part of the mine, highlighted by No. 1, 2, and 3 (these rock blocks are approximately 1.0-2.0 meters in size), and the primary safety bunds are marked as No. 5. The shear zone of the landslide in March 2023 is marked as No. 6, and the talus accumulation zone is marked with No. 4 in the Figure 5.

Fig.5. The rockfall in March 2023 and complicated geology. The location of the rock fall in March 2023 (a): No. 1, 2, and 3 are rock blocks from the pit walls, each with a size of 1-2 meters; No. 5 is the primary safety bund; No. 4 is the accumulation part, and No. 6 is the shear zone of the first rock fall in March 2023. Potentially dangerous rock block (b) marked with No. 8, and the shear zone of the first rock fall, marked as No. 7, along with details on the complicated geology. Rock blocks of limestone (size 15-20 meters) with a karstification zone on clay with medium or high plasticity form a collapsed cavern system in the 1st mine benches (c). Rock blocks (collapse breccia) at the edge of the south part of the mine (d). Loose, weathered, uncemented carbonate breccia (limestone blocks) with clay-lime cement.

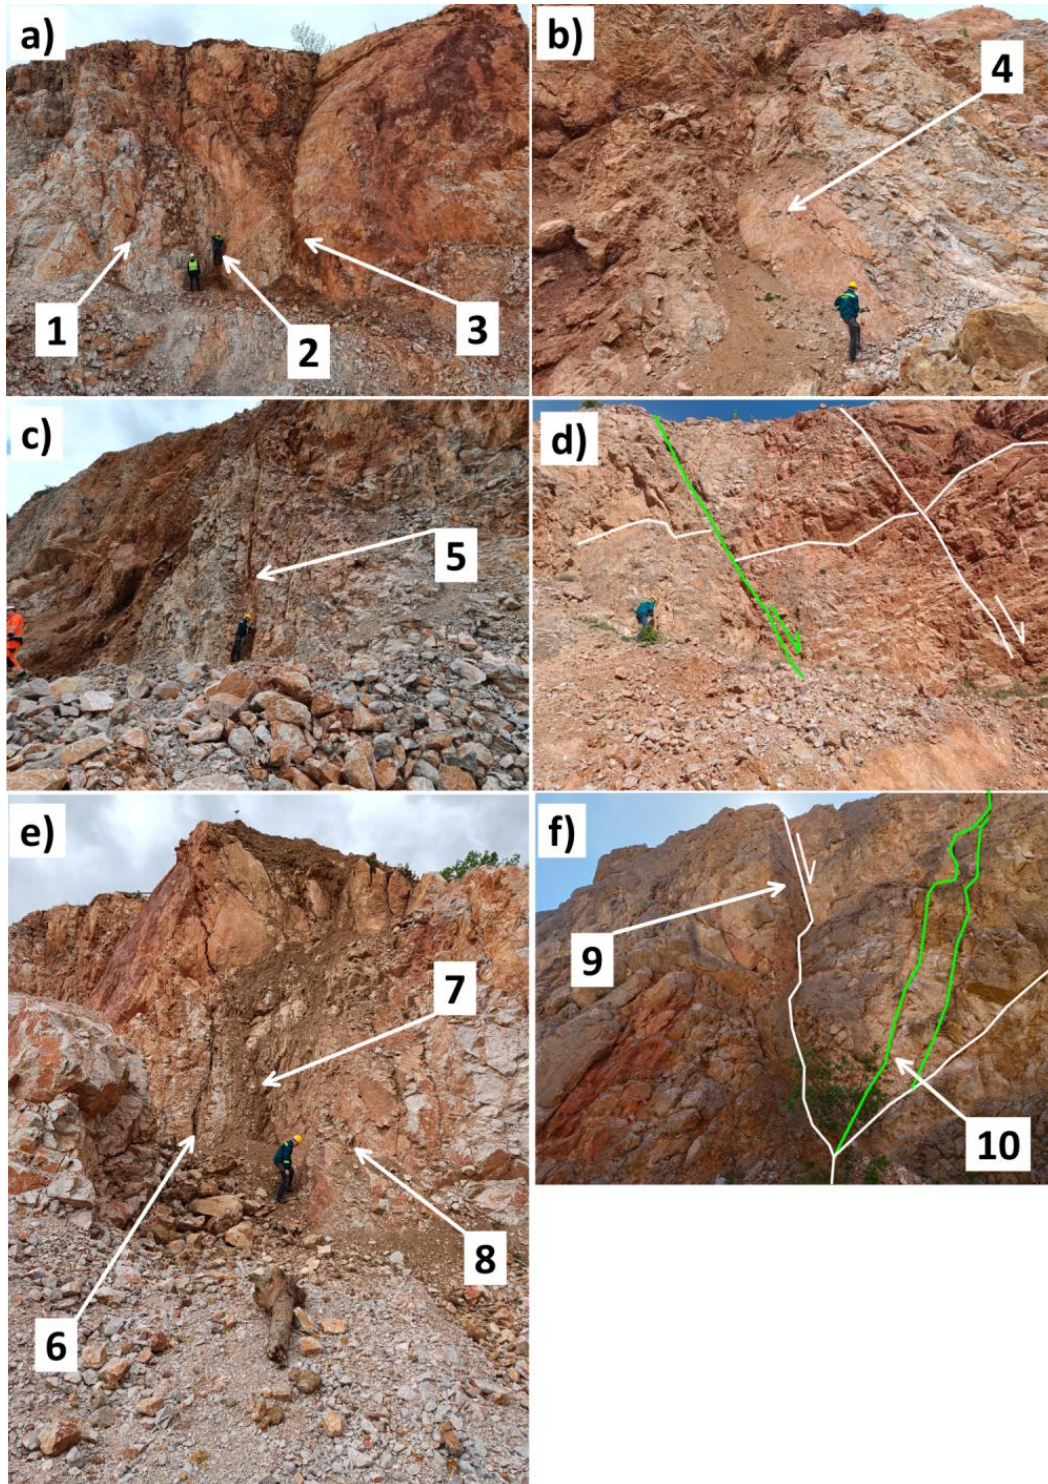
Fig.7. Documented structures (documentation points 1-3), wall of the 0th mine bench. Significantly karstified surfaces, partially covered with sinter, with coatings of Fe and Mn oxides. Between fault structures 1 and 3, a brecciation zone is developed, cemented with clay, with an oppositely oriented fault 2 (a). Fault structure on the 1st benches, dextral displacement, bounding a zone of intensely karstified, poorly cemented tectonic breccia cemented with brown clay, containing limestone boulders up to 1m³ (bottom right corner) (b) An older, steeply inclined fault structure with a nearly E-W orientation, filled with sinter and reddish-brown clay, intersecting the brecciation to crushing zone at the 0th benches (on the left) (c) The succession of fault structures documenting the unblocking of the massif. An older strike-slip and dip-slip fault structure is intersected by younger NE-SW dip-slip fault structures (d) The younger dip-slip N-S structure 1 terminates the older NE-SW structure, bounded by fault planes 2 and 3 on the II benches (e) The succession between the younger dip-slip N-S structure, which terminates the older NE-SW structure (green), at the level between the IV and V mine benches (f).

The genesis and evolution of the block structure in the Host'ovce mine are documented by the identified mutual relationships of fault structures at the IV mine benches (Fig. 7d). Relatively temporal relationships between steeply inclined structures in the E-W direction and NE-SW direction are exposed here.

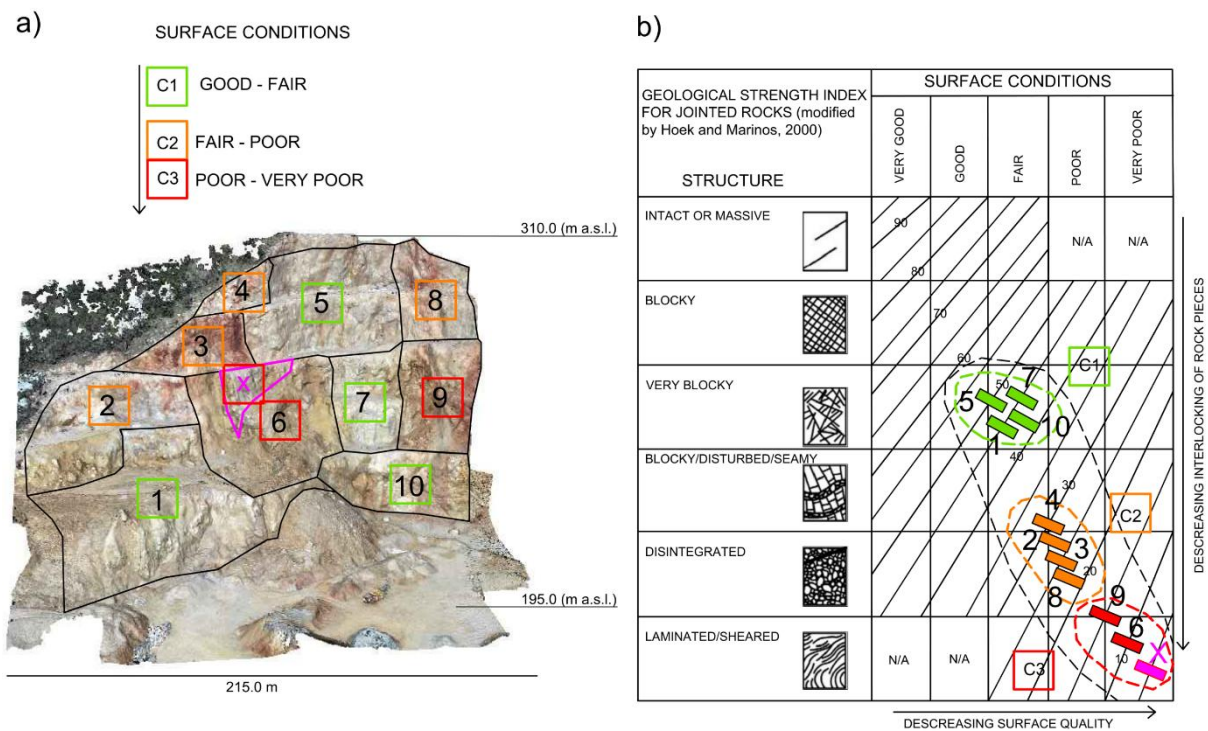
Fig.8. Classification of rock mass blocks in groups C1–C3 (from green to red), including unstable rock blocks (magenta), is based on the Geological Strength Index (GSI) for jointed rocks, as modified by Hoek and Marinos (2000). The categories of block groups C1–C3 are shown in the UAV mapping zone in the Host'ovce quarry (a), and the GSI chart (b).

Individual rock blocks were classified based on the GSI classification (Fig. 8b). According to this classification, three categories—C1 (green), C2 (orange), and C3 (red)—were identified (Table 1), considering the future potential for weathering, stability, and rockfall risk. A total 3D area of 44,876.0 m², derived from UAV mapping, was classified.

Group C1 (green) consists of rock blocks No. 5, 1, 7, and 10, with a GSI index ranging from 43.0 to 48.0%. Group C2 (orange), composed of rock blocks No. 4, 2, 3, and 8, has a GSI index between 23.0 and 28.0%. The final group, C3 (red), includes rock blocks 9, 6, and X, with a GSI index ranging from 8.0 to 13.0%. The total

From the perspective of the highest degree of tectonic damage and the most intensive weathering, Block X was selected. It has the lowest GSI index and experienced material fallout several days after the initial rockfall. Therefore, block X was classified as unstable and the most hazardous.

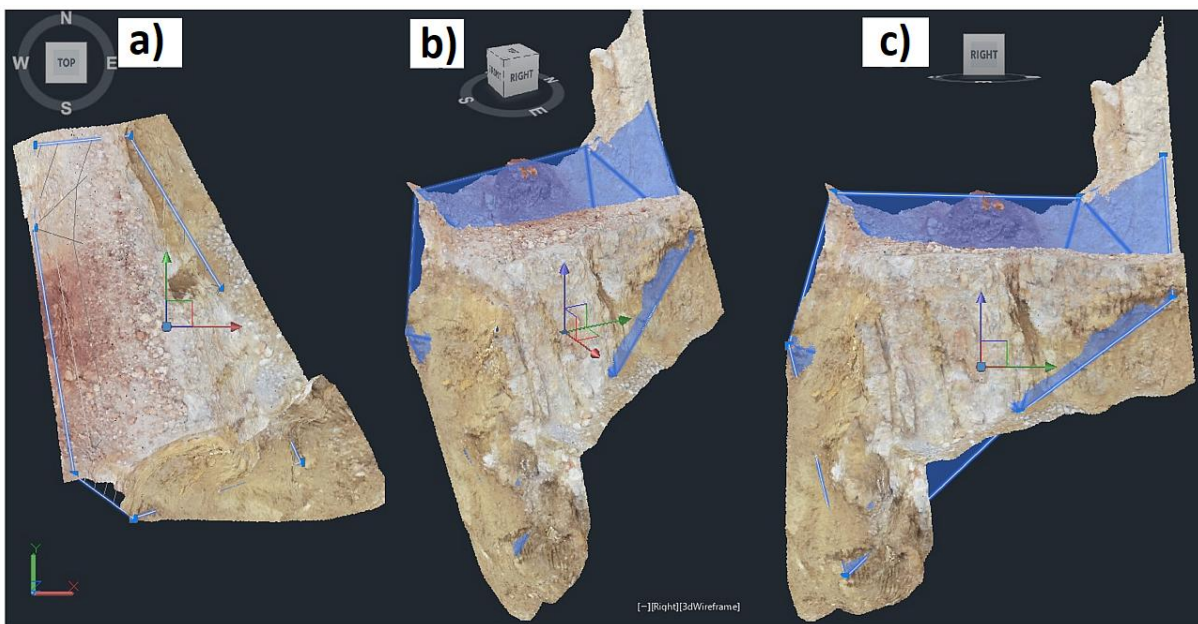
The calculation used Surface 1, created from a POINT CLOUD (generated from UAV photogrammetry), trimmed for the BLOCK (Fig. 9 a/b/c). The rock block consisted of a point cloud with a total of 38,742 points. The block boundaries were created based on geological-structural documentation and surveying data. These boundaries formed Surface 2, which was used in the comparison function of the Volumes Dashboard. By comparing the created surfaces, Surface 1 and Surface 2, the volume of the selected rock block was determined to be 3,099.59 m³. A total of 76,597 triangles of the irregular network were generated, based on which the volume was calculated.

Fig.9. Unstable rock block – different views unstable rock block (e) - top view, (f) - isometric view, (g) - side view Visualization in AutoCAD CIVIL e.g.

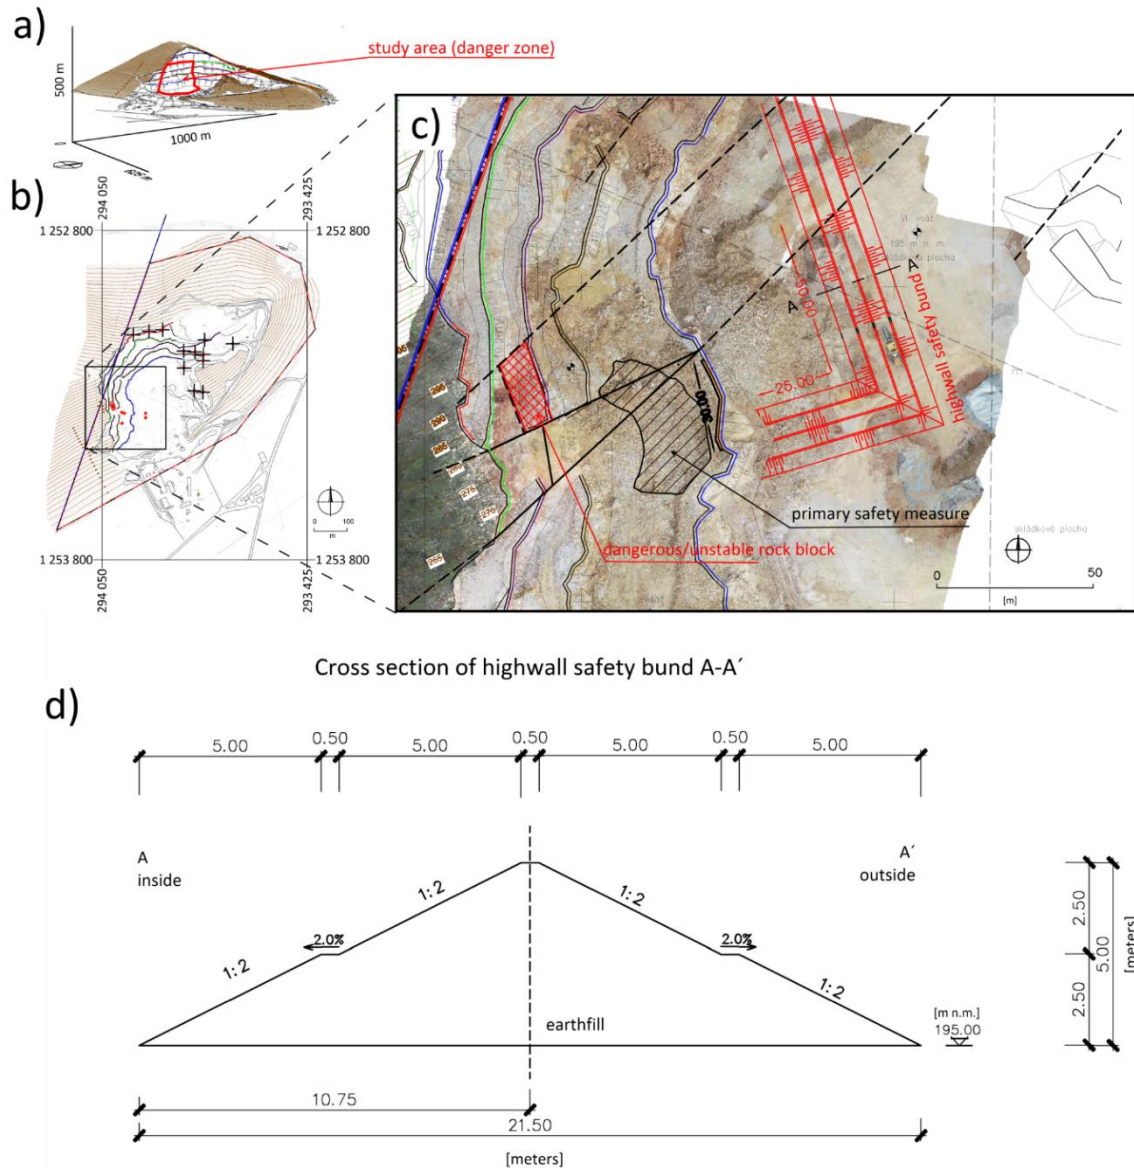
Fig.10. The selected rock block, with a volume of 3,099.59 m³, is bounded by blue surfaces between the IV and V mine benches, and its stability within the rock mass is uncertain following the collapse.

However, it is essential to note that in the event of a sudden collapse of the selected block, the loosened rock volume may exceed the capacity of the existing high safety bunds to contain it. Additionally, the current bedding plane does not extend beneath the entire selected block, which is compromised in terms of stability. As a result, the volume of rock that the safety bunds can capture is smaller than the volume of the selected block. In highwall mining, it is crucial to conduct a stability assessment of the slope before extraction activities, particularly when multiple layers are mined in a vertical sequence. Slope stability must be maintained throughout each phase of the operation. It is evident that the web cuts planned within each seam can significantly impact the overall stability of the highwall. The stability of quarry pit walls is directly dependent on the quality of the rock mass, and a comprehensive structural analysis of the rock mass is required before the commencement of excavation work. It is also necessary to monitor the quality of the rock mass during extraction in order to prevent unexpected events and risks to life and property.

The primary safety measure was constructed after a rockfall from March 2023 on the platform of the 5th mine bench (Fig. 10c), designed to catch individual falling boulders from the overlying rock collapse. Similarly, the volume of the selected block was calculated, and using TIN in AutoCAD CIVIL 3D, the volume of the existing bed on the 5th mine bench was computed to be 2,631.92 m³. Given the height of the collapse, rock falling may come from heights exceeding 40.0 meters. At the crest of the 6th mine bench, it is necessary to build a protective highwall safety bund. This embankment should reduce the potential scatter of boulder fragments when a boulder falls from height onto a boulder resting on the bed. The dimensions of the highwall safety bund are 50.0 meters in length and 5.0 meters in height (Fig. 10 c/d).

With a poor-quality rock mass (GSI values between 30.0 and 35.0), the volume of the existing high safety bund at the V mine benches (Fig. 10c – primary safety measure), calculated using AutoCAD Civil 3D and TIN modeling based on UAV photogrammetry, was 2,631.92 m³. This volume was found to be insufficient, leading to the design of a higher safety bund at the VI mine bench. Considering the height of the potential collapse, rock falls (such as from Block X, which has a GSI value as low as 7.50) could occur from heights exceeding 40.0 meters. Therefore, a highwall safety bund should be constructed (Fig. 10d) at the crown of the VI mine benches to reduce the potential spread of rock fragments when blocks fall into the safety bunds.

by extraction activities (technical seismicity) and could lead to sudden rock collapses (e.g., Block X). To mitigate this risk, high safety bunds measuring 5.0×50.0 meters were proposed on the VI. mine bench to intercept falling rock material.
