Technical condition diagnosing of the cableway supports' foundations

The paper presents a test subject, which is a set of cableway support towers, and issues related to its diagnostics. The paper's essential part of the paper concerns proposed method for evaluating technical condition of joints between tower's supporting structure and its foundation, which is based on vibrations' acceleration of joints' elements tests results analysis. The final part presents analysis results for one of tested supports, obtained before and after an overhaul.

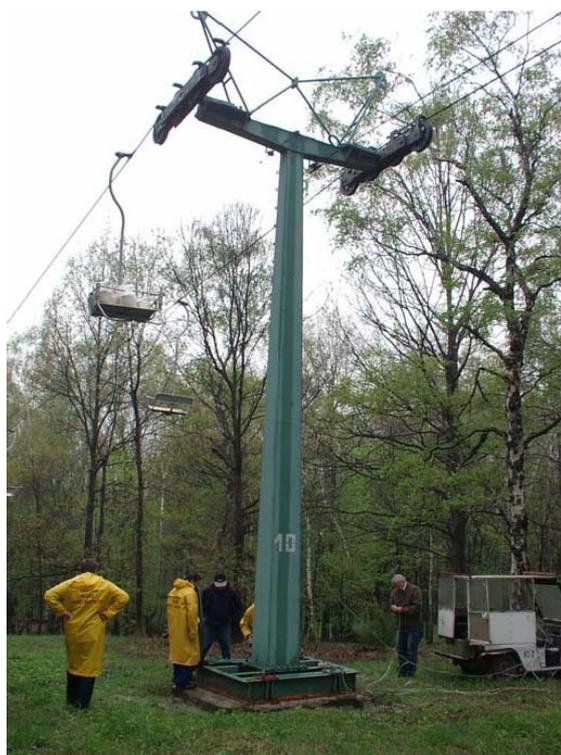
Fig. 1. A view of tested cableway's support tower.

This caused a heterogeneity in concrete structure, with individual layers varying in quality. A photography of one of tested support towers is shown in Fig. 1.

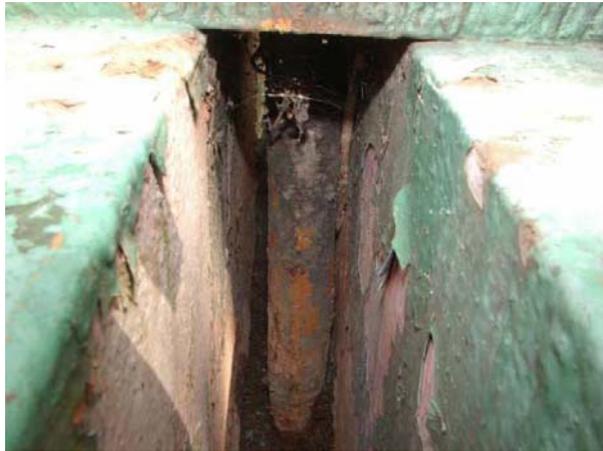
Fig. 2 shows a place of mounting support to foundation with an anchor. It can be seen, that elements of steel construction are highly corroded.

Fig. 2. A joint of support structure and foundation.

support tower requires an overhaul to make joint between it's construction and foundation more rigid. The overhaul was primarily a strengthening of supports' construction, and installation of additional strengthening anchors. Results of the conducted overhaul were tested by a new evaluation of foundation supports' technical condition.

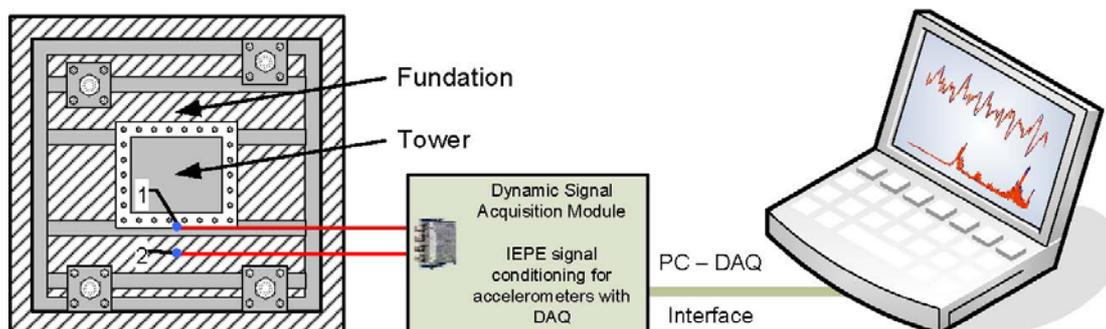
In attempt to select defected supports for repairs, a method based on measurements of their vibrations' acceleration was proposed. Acceleration of vibrations for each foundation and support was measured simultaneously, at maximum load and rated velocity of the cableway. Cableway's chairs were loaded with sandbags in order to reach maximal load capacity. A scheme of measurement system along with marked sensors (1 and 2) is presented in Fig. 3.

Fig. 3. Measurement diagram.

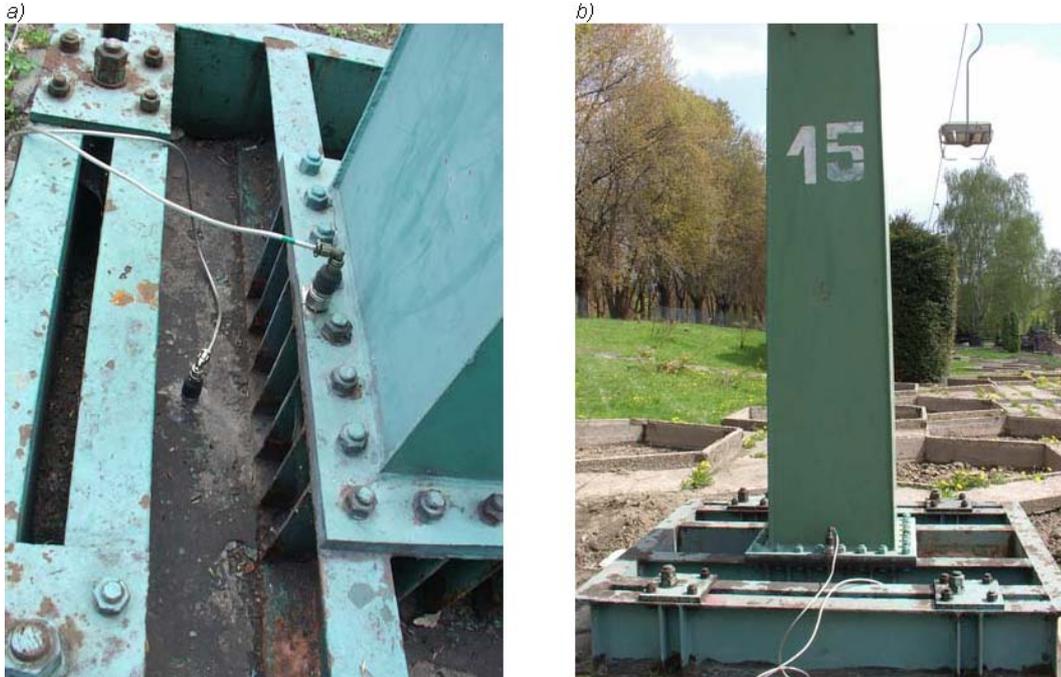
A way of fixing vibration sensors to tested elements is shown in Fig. 4.

Fig. 4. A layout of sensors on tested elements: a) detailed view, b) overall view.

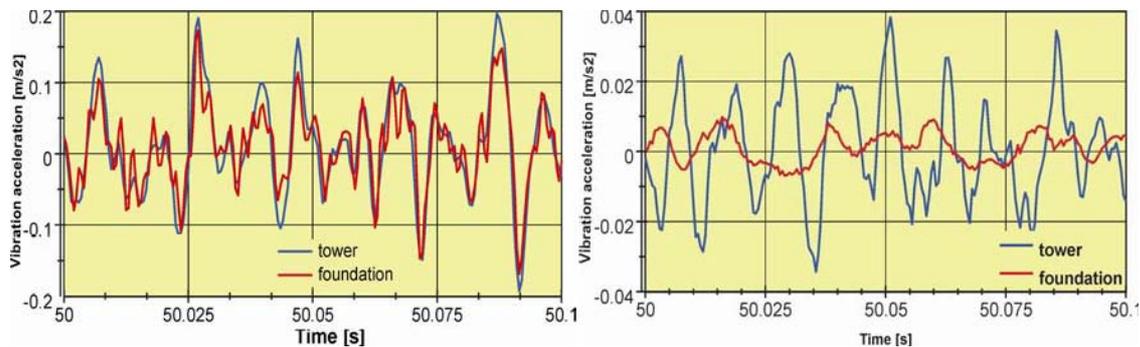
In correct case, that is when the joint between the foundation and the support is rigid, time functions of vibrations' acceleration should be coherent, regarding amplitude and phase. If backlashes in their joints occur, amplitude of support vibration's acceleration is higher than amplitude of foundation vibration's acceleration. Moreover, there is no coherence in phases of accelerations. The fragment of time functions of support and foundation vibrations' acceleration for two chosen constructions (no. II.13 and III.5) was shown in Fig. 5 and 6.

Fig. 5. Time functions of vibrations' acceleration for Fig. 6. Time functions of vibrations' acceleration for construction no. II.13 construction no. III.5.

Fig. 5 shows relatively high consistency of support and foundation vibrations' acceleration. It can be concluded then, that foundation II.13 does not need repair (remontu). However, an analysis of time functions which fragment is presented in Fig. 6 enables the conclusion, that the joint between foundation and support no. III.5 is damaged.

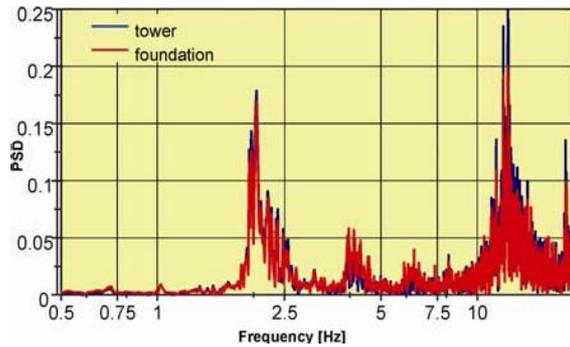
Weakening of the tested joint can also be observed on power spectrum density (PSD) characteristic of measured signals'. Those characteristics are presented in Fig. 7 and 8 consequently for constructions II.13 and III.5. Too high discrepancy between tower and foundation PSD characteristic can indicate an occurrence of backlashes in this joint.

Fig. 7. Power spectrum density function for vibration's

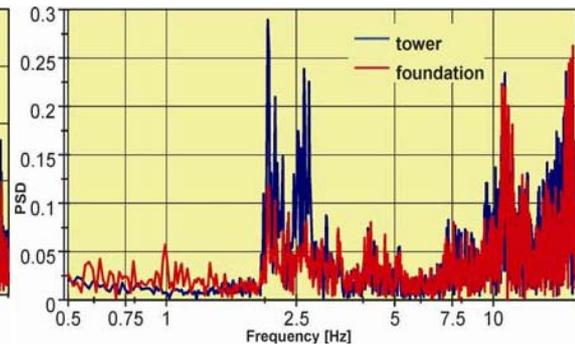
Fig. 8. Power spectrum density function for vibration's acceleration for construction no. II.13 acceleration for construction no. III.5.

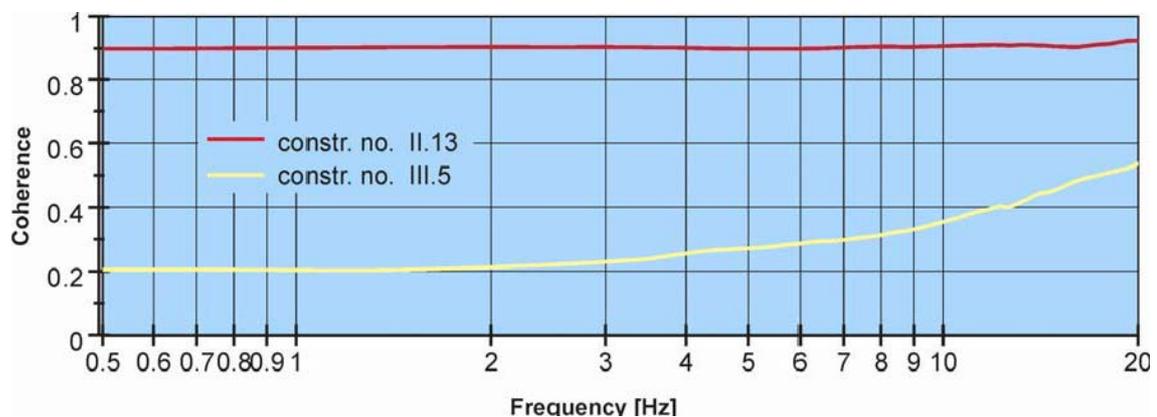
Evaluation of coherence function is obtained basing on determined estimates of power spectrum densities, and reciprocal spectrum densities (Bielńska, 1997; Bendat, 1976). Coherence functions for support and foundation vibrations acceleration's signals for constructions no. II.13 and III.5 are presented in Fig. 9.

Fig. 9. Analyzed constructions coherence function for foundation vibrations in respect to support vibrations.

The most important frequency band, for the cableway's support tower, includes it's natural frequency, which is an individual characteristic for each one of supports. Therefore, a value of coherence function for a natural frequency was chosen as an evaluation criterion. After an analysis of all support towers' test results, $\zeta = 0,75$ was established as a boundary value. For values below this one, it was acknowledged, that tested

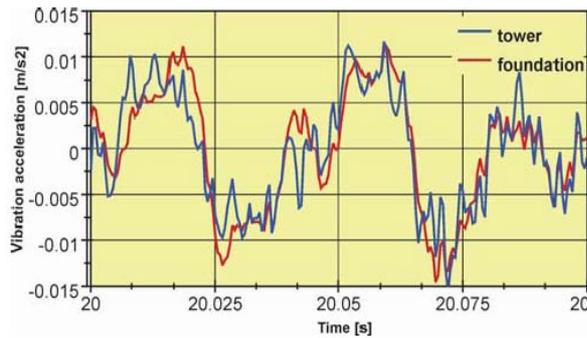
The fragment of time function of support and foundation vibrations' acceleration, after the cableway's overhaul was shown in Fig. 10. A high consistency between support and foundation vibrations' acceleration can be observed. From the presented fragment of time function it can be seen, that amplitudes of support and foundation vibrations' acceleration have similar values.

Fig. 10. Time functions of vibrations' acceleration for construction no. III.5 after the overhaul.

After the overhaul specified basing on construction measurements, diagnostic tests were conducted again.

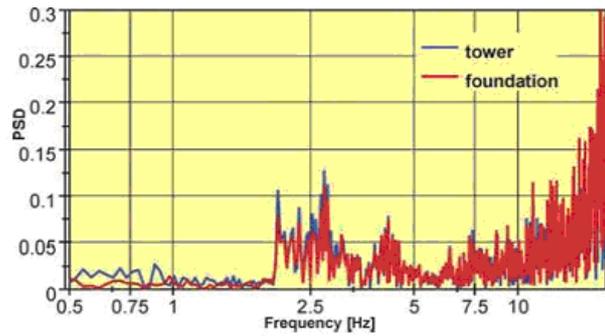
In order to check consistency of those amplitudes in full frequency range, a power spectrum density (PSD) characteristic, shown in Fig. 11, was created.

Fig. 11. Power spectrum density function for vibration's acceleration for construction no. III.5 after the overhaul.

It confirms an improvement of rigidity of the joint between foundation and support in tested frequency range. Improvement degree was evaluated by comparing coherence functions before and after the overhaul of the support no. III.5. Coherence functions for support and foundation vibrations acceleration's signals, before and after the overhaul, are presented in Fig. 12.

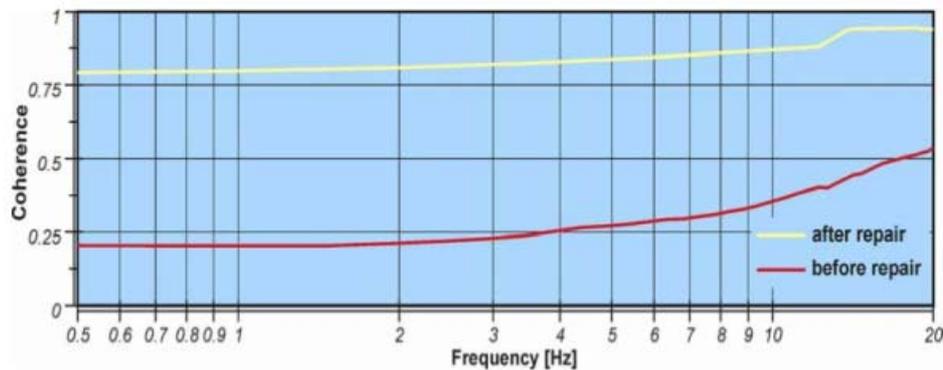
Fig. 12. Coherence function for foundation vibrations in respect to support vibrations before and after the overhaul.

Increased value of the coherence coefficient for the free vibrations frequency from 0.21 to 0.81 can be observed. It is a significant improvement in comparison to the value from before the overhaul.
