Numerous landslides and landslide restorations – an example

Božo Soldo¹, Krešo Ivandić and Matija Orešković²

Key words: landslides, infiltration, site investigations, construction, restoration concepts.

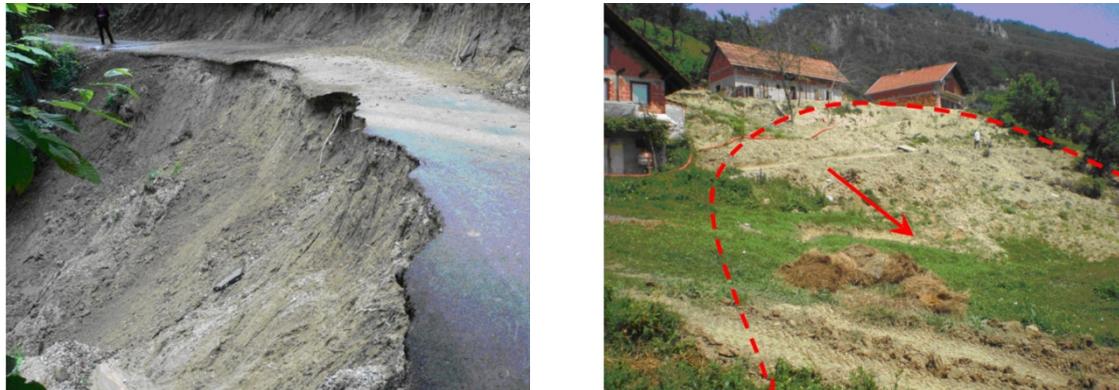
Fig. 2. Typical landslides in the Bednja area:
 2A) Most frequent appearances at road bends; 2B) Often landslides will happen beneath houses.

Road landslides most often occurred on road bends. In fact, the starting point of the slide was at the most curved point of the road, where the surface water from the slopes above the road flowed into the lower slopes (slopes beneath the road).

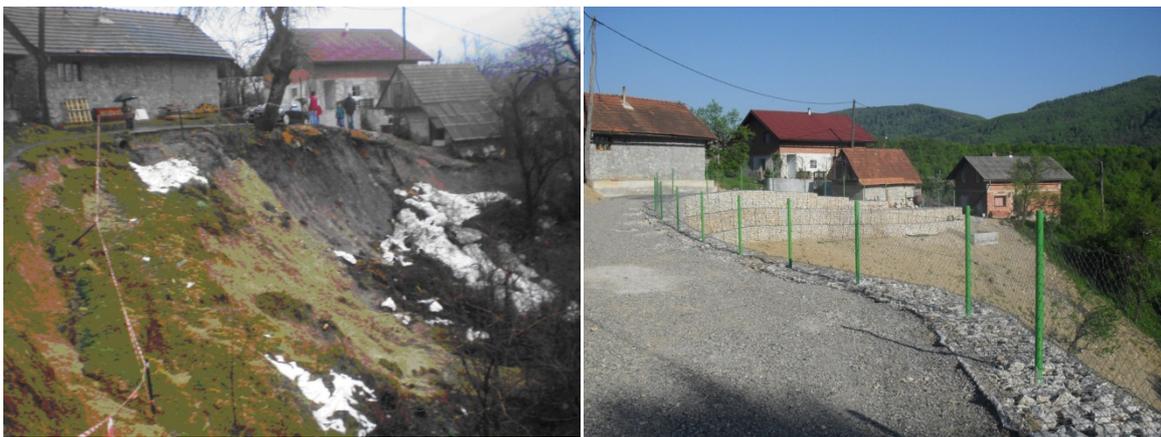
Fig. 7. Example of restoration solution for the landslide:

7A) Ground plan of restoration, 7B) Typical most frequent cross-section of restoration

- digging a number of drainage points (the bottom of these drainage points must be below the sliding layer),
- partial (and in some cases, full) substitution of damp or slid soil materials from the road and the contact area,

- micro-pile security of endangered structures, and if necessary, building micro-pile foundations for the gabion wall,
- construction of a flexible gabion wall on points of higher terrain denivelation, (gabion walls are most often built parallel to road axes),

- installation of special materials (geo-textiles etc.) in certain areas, if necessary,
- ballast relocation of soil masses (unburdening the frontal and adding weight to base zones of landslides),

- constructing the system of surface drainage, with controlled drainage flow to the appropriate recipient,
- arranging/beautification of the restored/repared terrain, including planting appropriate plant life (for solidifying the soil and increasing evapotranspiration),

- setting up the monitoring system,
- maintaining and putting finishing touches on the restored area.
