# Cuban marble slabs exposed on a building facade for 40 years: Mineralogical and geological characteristics, re-use and recycling challenge

Marble slabs obtained from Cuba covered the facade of a cultural center in Bratislava, Slovakia, for 40 years. The recent demolition of the building enabled laboratory testing of slabs, separately from the southern and northern facades. Regarding the environment, re-use/recycling options were analyzed to minimize waste and save construction materials. This applied research started with visual evaluation and mineral analysis, and continued with laboratory determination of selected physical properties. Different thermal conditions (direct sunlight only on the south) resulted in different properties and a higher-quality marble on the northern facade. The marble slabs from the northern facade are suitable for decorative cladding and flooring, but with a thickness of 30 mm, they can only be used for pedestrian areas. Crushing them to waste marble aggregate looks more promising. Susceptibility tests, micro-Deval, and Slake Durability tests indicate the effective substitution of natural aggregates in the production of different concrete products and

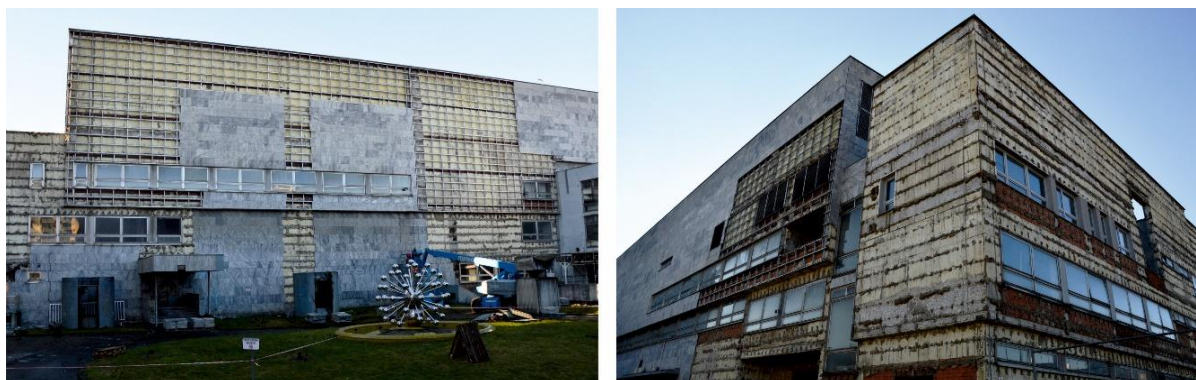
In the second half of January 2022, demolition of the Istropolis building began, starting with the removal of the exterior marble cladding (Figure 2).

Fig. 2. Removal of the marble cladding from the Istropolis building (photo: Ružička, February 2022)

Several dismantled marble panels with dimensions of approximately 650 mm x 440 mm were taken to the rock-mechanics laboratory. The panels were approximately 30 mm thick. Test specimens were prepared from the panels by cutting and drilling into plates, prisms, cubes, or cylinders according to the requirements of the standard test methods (Figure 3). Specimens were prepared and tested separately, depending on whether they came from the south or northern facade of the building.
