Importance of drill string assembly swivel in horizontal drilling

A part of the drill string – the swivel (rotational connector) – accomplishes an important task in the horizontal drilling. Its malfunctioning makes it impossible to draw in (install) large diameter and length pipelines. The causes of the connector break-down during the horizontal drilling are investigated in the paper. The drilling has been made for twenty inches gas pipeline installation during reaming operations. A trouble was encountered making good work conditions of a system consisting of the drilling machine drill string reamer swivel tube shield of Cardan joint and the gas pipeline 500 m long. In this case, the swivel brokes down and the planned operation was not finished. The assessment of improper drilling conditions, selection of operation system components, and drilling parameters and the insufficient technological supervising have created an excessive risk of failure. A proper application of technical analysis would considerably decrease the hazard of failure which cause large costs, delays and decrease of confidence to the drilling contractor and pipeline installation.

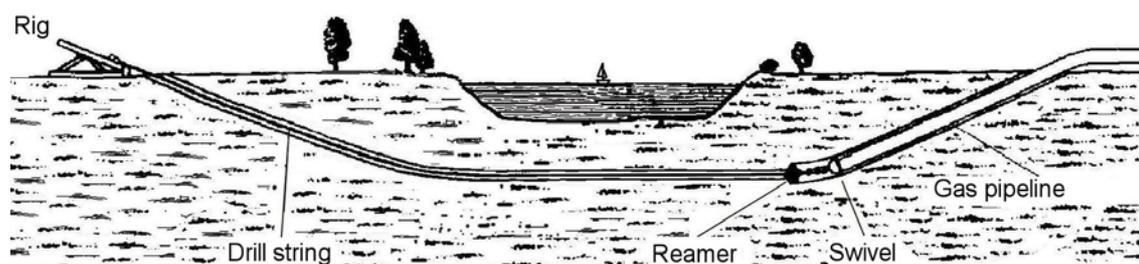
The first part of the drilling was made with a bit 200 mm in diameter (pilot), to be later reamed three times to the diameter of 450 mm, 650 mm and 900 mm, respectively. Owing to the uncoordinated operation, the idle time was about two weeks. At that time, no casing was tripped to the well 900 mm in diameter and about 500 m long. Some rock slide was observed, a reamer 900 mm in diameter was used and a pipe 508 mm in diameter started to be tripped inside (Fig. 1). At a distance of 40 m and 60 m from the target side the pipe got stuck in the process of tripping. After doing away with this problem the pipe was finally tripped inside (according to the reports, the tractive force was 18 tons, and the torque 10 000 Nm). At a distance of 60 to 445 m the tripping operation went on smoothly, with a continuous increase of the tractive force to 35 tons and the constant torque 10 000 Nm. At a distance of 445 m the pipe was stuck. First, the advancement decreased to 0.4 m/h to finally stop. At that time the tractive force was ca. 35 tons and the torque 25 000 Nm. At the end of the dragging operation at a distance of 445 m to the end the pipe got stuck. Further attempts to move and trip the pipe were futile. At a tractive force of about 100 tons the rotary swivel was damaged.

Fig. 1. Horizontal directional drilling.
