Dangerous Planar Rockfall in an Open Pit: A Case Study from Host'ovce Quarry, Slovakia

Jaroslav BUŠA^{1*}, Julián KONDELA², Roman FARKAŠOVSKÝ³ and Stanislav JACKO⁴

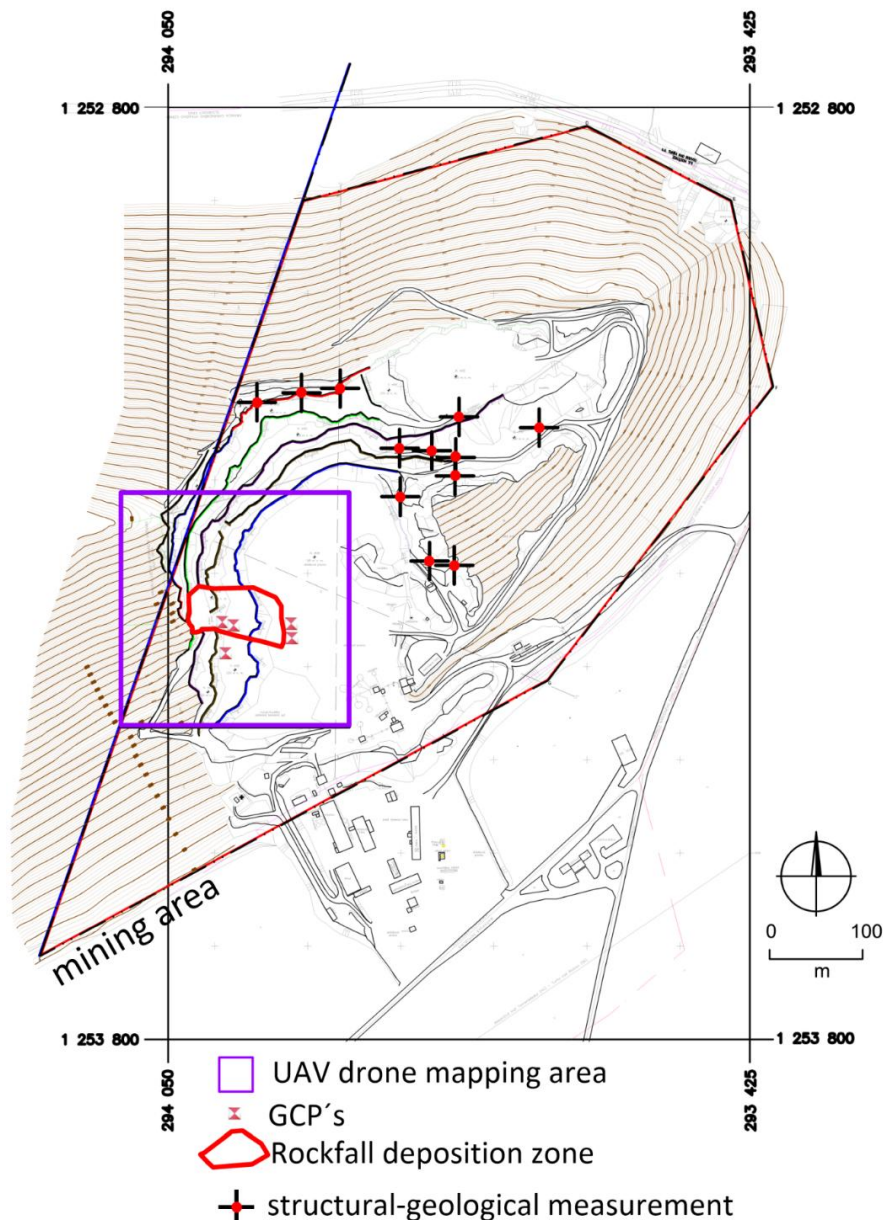
Structural mining mapping and geological research involved measurements and documentation at various quarry levels using geological compasses in areas where access was safe. The location of each measurement was made at safe locations (Fig. 2).

Fig.2. The basic mining map with field documentation points in the Host'ovce Quarry. Topography is sourced from the basic mining plan (chief mining surveyor Ing. Thuróczy).

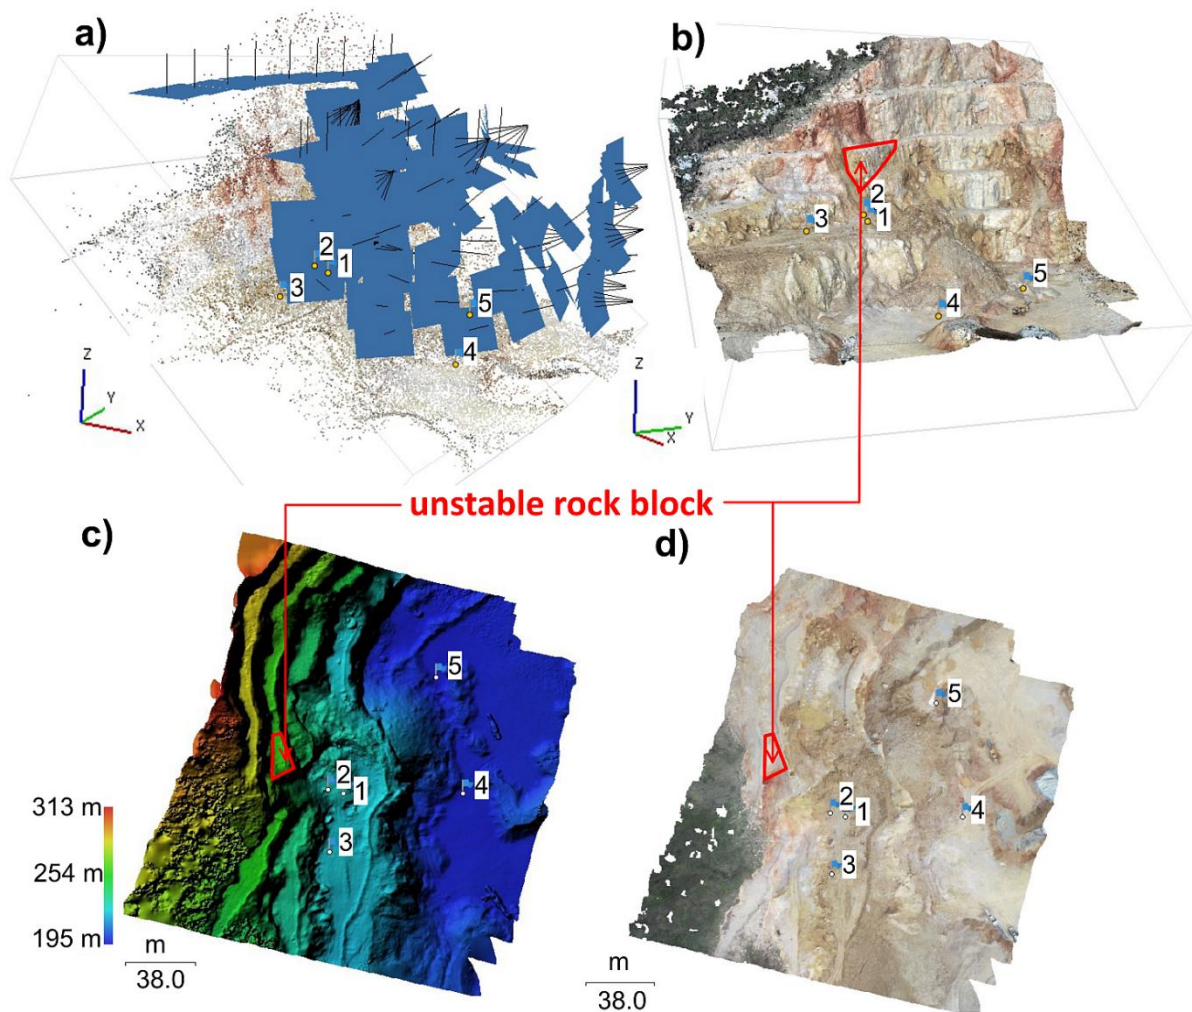
Agisoft PhotoScan software then processed the 180 images. When images were aligned and tie points generated, the Structure-from-Motion (SfM) algorithm (Snavely et al., 2008) was used to build model geometry (image orientation and exterior orientation). Ground control points provided spatial georeferencing and accuracy estimation, and orthophotos, and a colored point dense cloud of 8,254,575 points was generated for DTM calculation. The terrain model with 9,06 cm pixel resolution and 2 cm vertical and horizontal accuracy was thus generated. Individual parts of the DTM creation and the orthophotomosaic are shown in Figure 3a-d.

Fig.3. The tie points 74 688 and camera alignment and flight paths above the pit wall, with flying heights of 35 to 65 m above ground level, respectively (a). The dense cloud with 8,254,575 points (b). Visualization of digital terrain model (c), orthophoto mosaic (d).

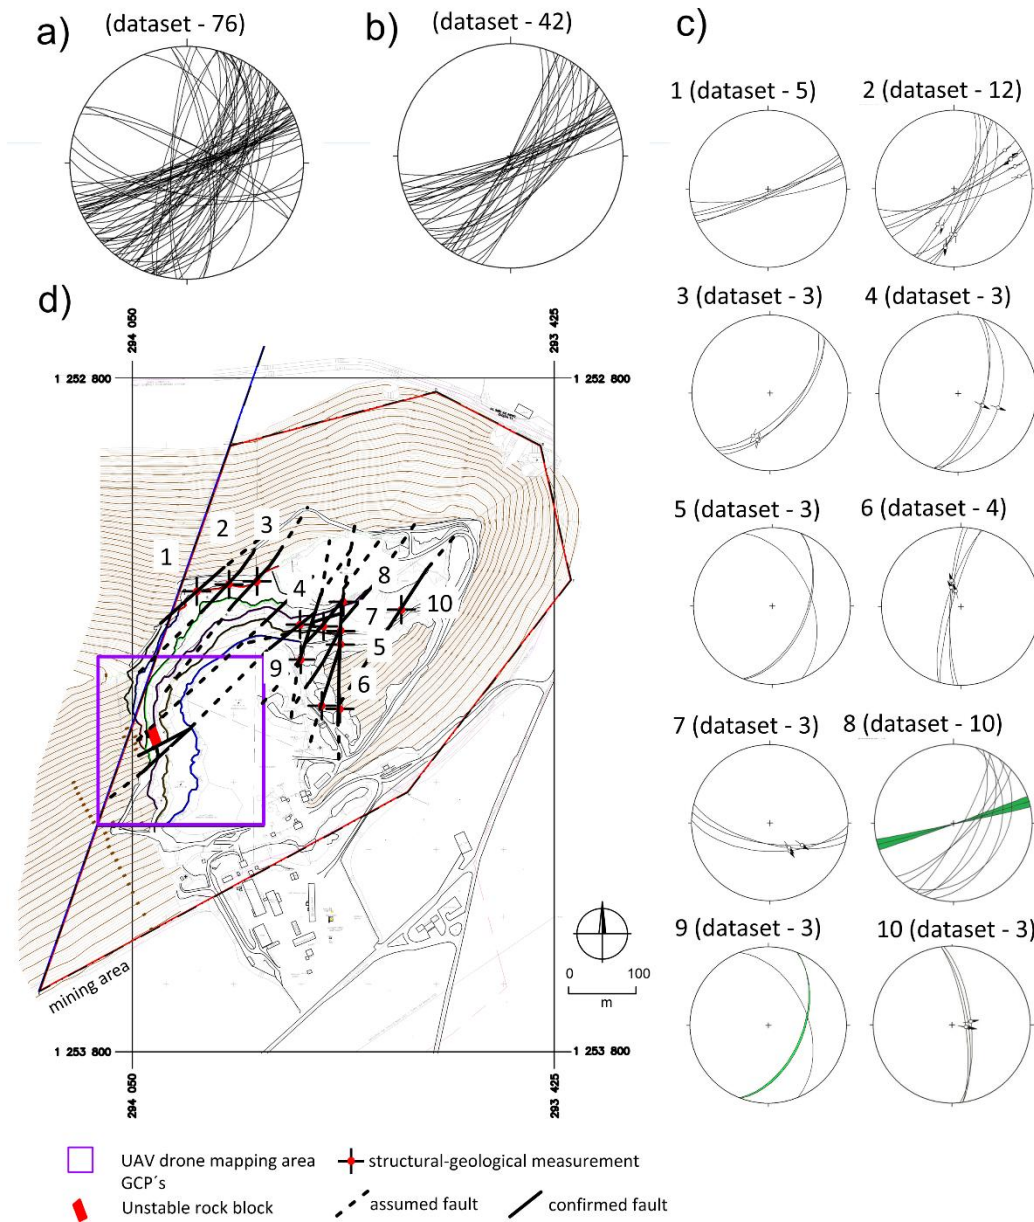
The dominant structural system on I and II mine benches consists of planar fault structures, occasionally with linear elements, oriented in the NE-SW direction with a moderate to steep dip towards the SE (Fig. 6a). These planar elements in most cases represent secondary fault structures, occasionally with preserved striations of movement in brittle conditions. The faults have the character of dips or oblique (dextral) displacements (Fig. 6b). In these structures, tectonic breccias with angular limestone fragments are irregularly situated, cemented with carbonate mineralization or reinforced with clayey material.

Fig.6. Map of the study area in the quarry. Great circles in stereoplots illustrate fault data. The tectonogram of all measured fault structures in the Host'ovce mine (a). Structural elements dominating the upper mine benches (I, II, III, IV, V) of the Host'ovce mine are fault planes oriented in the NE-SW to ENE-WSW direction, with a moderate to steep dip towards the SE (b). The individual tectonograms (c). The map of structural measurements with the UAV mapping zone (d).
