## Decontamination of a waste dumpside of s.p. DIAMO

**Abstract:** The article indicates possible methods to remedy environmental damage in the Ostramo Lagoon locality. Authors deal with the description of locality, composition of waste and description of current work performed in decontamination of this locality. The article describes also the technical solution of decontamination of the territory and recommendations for possible future use of the decontaminated areas.

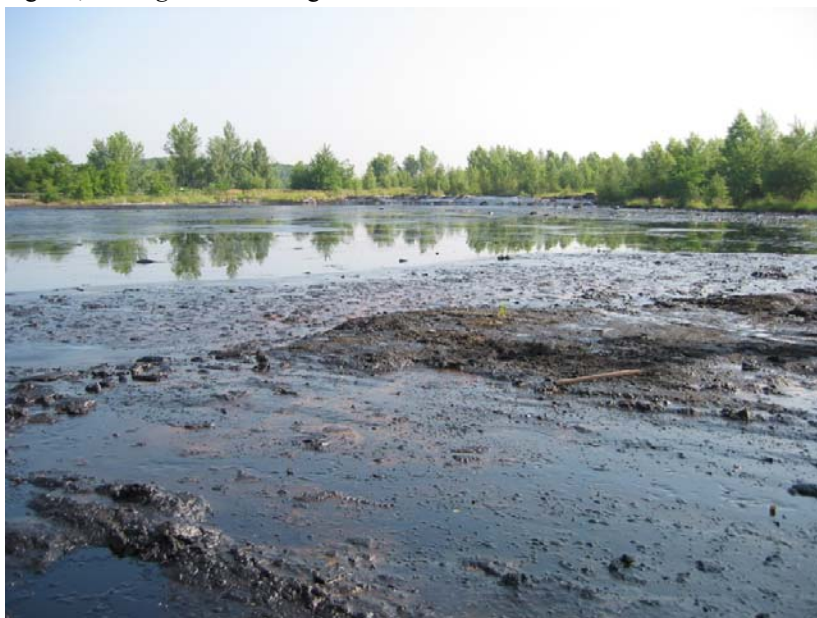
*Fig. 1. General view of the locality of Ostramo Lagoons in Ostrava.*

There are places that would be best forgotten. Localities that seem to have never existed. These areas are many times referred to as old damage. People put off their reparation and tried not to see, not to handle, to forget. But they remained, the problem did not go away, it only slowly and inevitably grew bigger. Such old damage includes among other places also places located in the Moravian-Silesian Region. In this part of the Region on the cadastral territory of Ostrava-Mariánské Hory and cadastral territory Ostrava-Přivoz, City of Ostrava, District of Ostrava-Město there is a waste dumpsite. It is known as a waste disposal site of s.p. DIAMO, from the past better known as so-called Ostramo Lagoons in Ostrava, (Fig. 1).

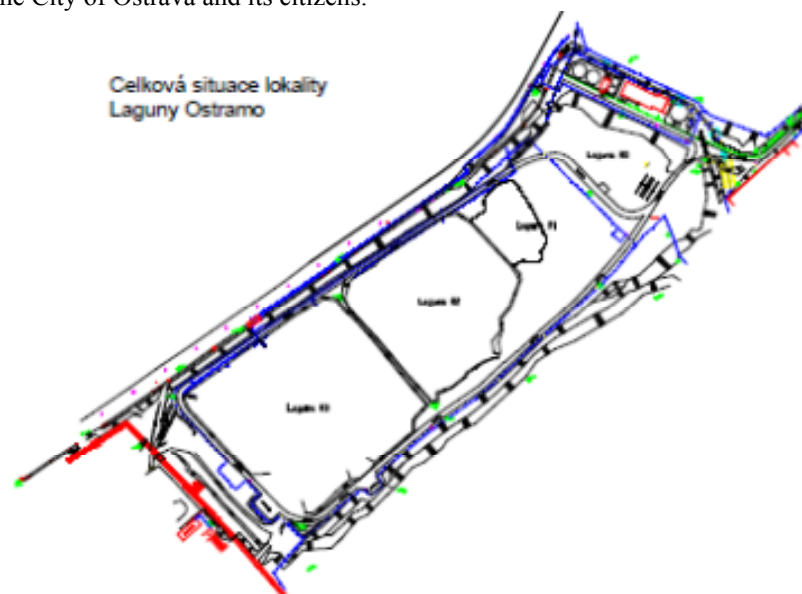
Fig. 2. General layout of the locality Ostramo Lagoons in Ostrava.

The waste dump is enclosed within the range of lagoons marked R0. This is the oldest lagoon, in which semi-solid waste was detected under the landfill. It is not separated with an underground supporting wall ("Milan" wall). Lagoons R1, R2, R3 are enclosed with "Milan" underground walls on the perimeter. Their purpose was to isolate the surrounding environment and function as a seal. Insulation function of Milan walls, like other man-made works, is limited in time and therefore requires reconstruction, separation of the lagoon, see *Figure 2*. The lagoons are located in an industrial zone on the right-bank side of the alluvial plain

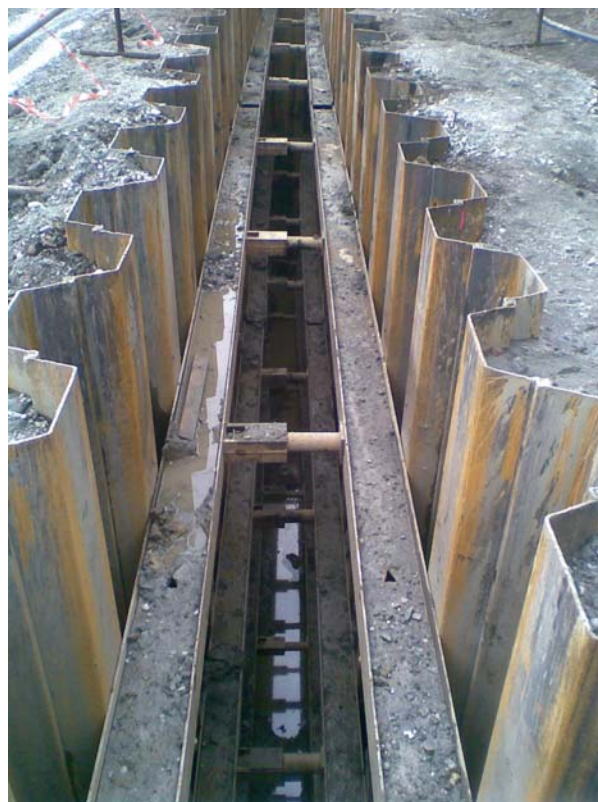
*Fig. 3. Construction of excavation for a drainage rib supported by sheet pile walls.*

A drainage system for decontamination of the territory, see *Figure 3*, was built at the lagoons during implementation of emergency remedial measures. This system was efficient and it was necessary during the construction of the drainage rib to comply with safety measures in connection with detected presence of methane. It was necessary to have specialized safety supervisors present and get informed about the methane risk in the given locality. It was necessary to observe and comply with the quality of backfill material used, its compacting during the construction of the rib. Then lowering of groundwater level was monitored during decontamination pumping to prevent movement of contamination further down to less contaminated terrace gravel. Extraction was done in decks (levels) and soil was closely monitored all the time from the contamination point of view. Heavily contaminated soil was separated from less contaminated soil.

Work was performed in six sections, which were prepared beforehand according to work schedule and each was closed by a transverse wall. Maximum level of excavation was always 0.5 meters under then installed level of spreading structure. One spreading structure was installed at one level and subsequently

excavation at the lower level was performed. On the other hand the spreading structure was removed, which was done upon completion of backfill up to the next level. By building the sheet pile walls it was possible to build a drain for which a trench was made. Excavation of the trench using earthwork support and leveling of the trench bottom enabled subsequent installation of drainage pipes at two levels. The drainage pipes were subsequently controllably covered with drainage material. The drainage rib was filled with crushed aggregate (gravel) of 32 – 63 mm fraction at two levels of height. Pumping and inspection manholes were built under the protection of walls. Inspection pumping concrete sumps were spaced 60 meters apart and placed in the line of the rib. They were made of pre-fabricated parts equipped with a ladder on the inside. The prefabricated parts were 800 mm in diameter. The height of the tops of sumps had to be aligned with the surrounding terrain and they were covered with steel lids, which were lockable. Larsen-type sheet piles were used in the locality. Pipe spreaders were used for strutting, which through a strap anchor enabled gradual excavation of the trench. Rams were diesel-powered, high-frequency non-resonant and vibration type. High-frequency types are conveniently used namely for redevelopment work in built-up areas.
