Utilization of Result of Trial Seeding Experimental Plots in the Course of Rehabilitation of Central Tailing Heap of Ján Šverma Mine in Žaclěř

Vlastimil Hudeček¹, Kristýna Černá and Zdeněk Adamec²

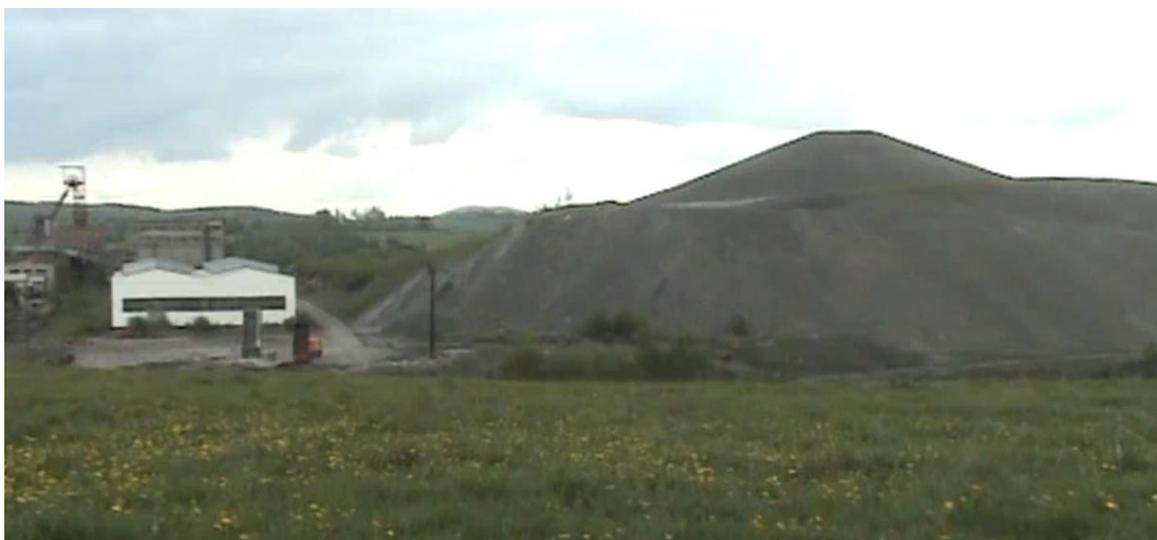
Fig. 1. Central Tailing Heap [1].

The Central Heap was constructed in the year 1930, when materials began to be piled up on the Heap manually by means of cars, and later in the 40's and the 50's, the Heap was shaped conically; the height from heap bottom is 64 m. [1]

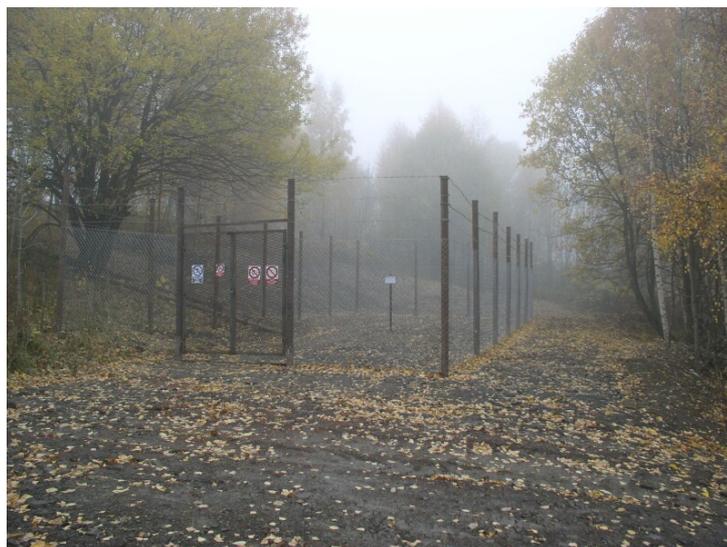
Fig. 2. Eliška Heap [1].

The Heap is situated north-north-west of the premises of Jan Šverma Mine near an approach road. The Eliška Heap consists of tailings from extractive industries and bands in hard coal. Deposition took place in the years 1867 – 1920. In the mid-seventies of the 20th century, spontaneous combustion occurred in the Heap. At the top of the Heap, an area about 20 x 20 m in size still exists, where temperature differs evidently from that in the surroundings – during the winter months any mantle of snow does not remain here. At present, the heap is covered with self-seeding trees and shrubs with the prevalence of birch trees. The area is secured partially by fencing to prevent unauthorized persons from entering. [1]

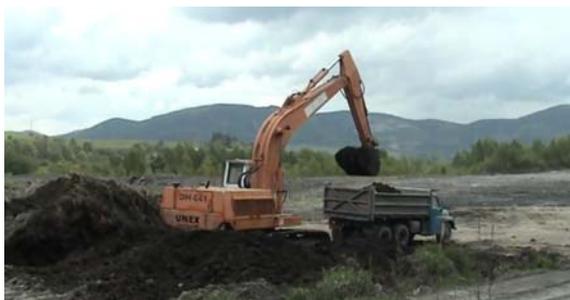
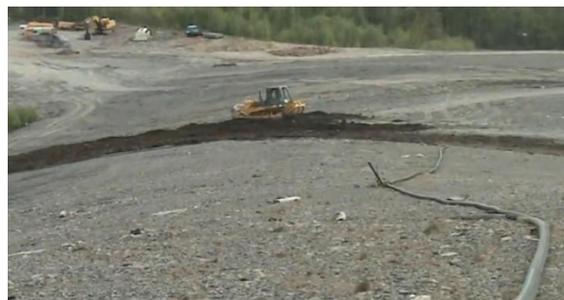
At first it was necessary to shape the heap so that stability might be achieved and the uncontrolled running down of water during prolonged or heavy rains might be prevented. For this purpose, heavy machines were utilized (loading shovels, dozers) by means of which levels and sloping surfaces were formed. [1]

Fig. 3. Machines in operation on the Central Heap [1].

Fig. 4. Machines on the Central Heap [1].

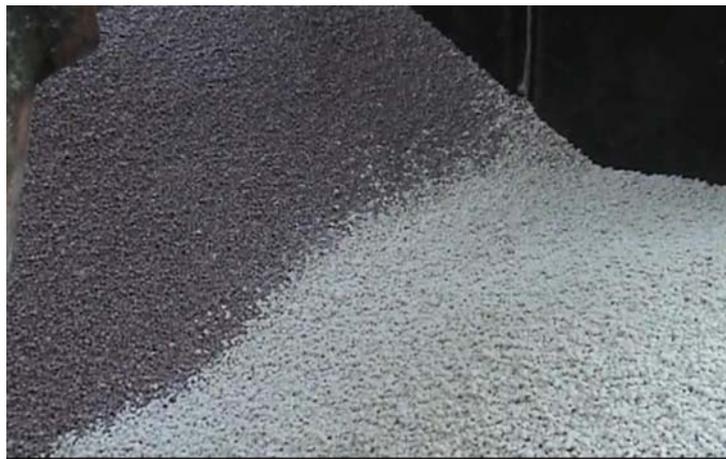
On the basis of knowledge of specific properties of the site, a drought proof clover-grass mixture for extensive non-agricultural utilization was proposed for the model experiment. The composition of the mixture is as follows:

Sheep's fescue	30 %
Tufted red fescue	15 %
Short creeping red fescue	10 %
Creeping red fescue	15 %
Sweet vernal grass	10 %
Rye-grass	5 %
Clover crops	15 %

Fig. 5. An example of clover-grass mixture and fertiliser [1].

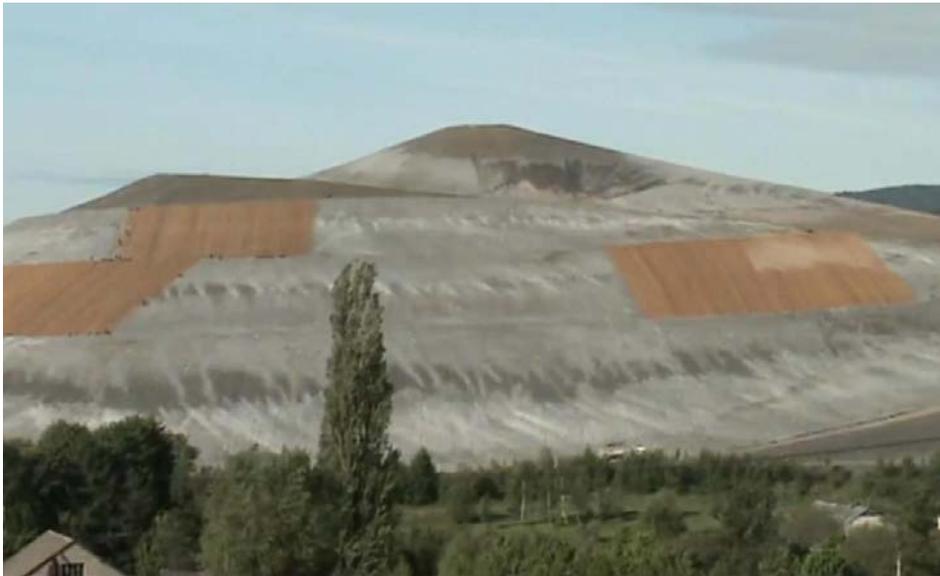
After application, a continuous layer of a sprayed mixture with an elastic film of admixture for erosion prevention will be formed on the soil surface. The Central Tailing Heap has the highest gradient of 28 degrees and hydroseeding could be carried out by means of ways constructed for practical reasons along the circumferential contour. [1]

Fig. 6. Central Heap after hydroseeding and coconut mats [1].

The steepest places were covered with coconut mats imported from Sri Lanka. They are fastened through oak bolts to avoid rather large local landslides. These mats will decay in several years and the function of them will be replaced gradually by greenery grown. [1]

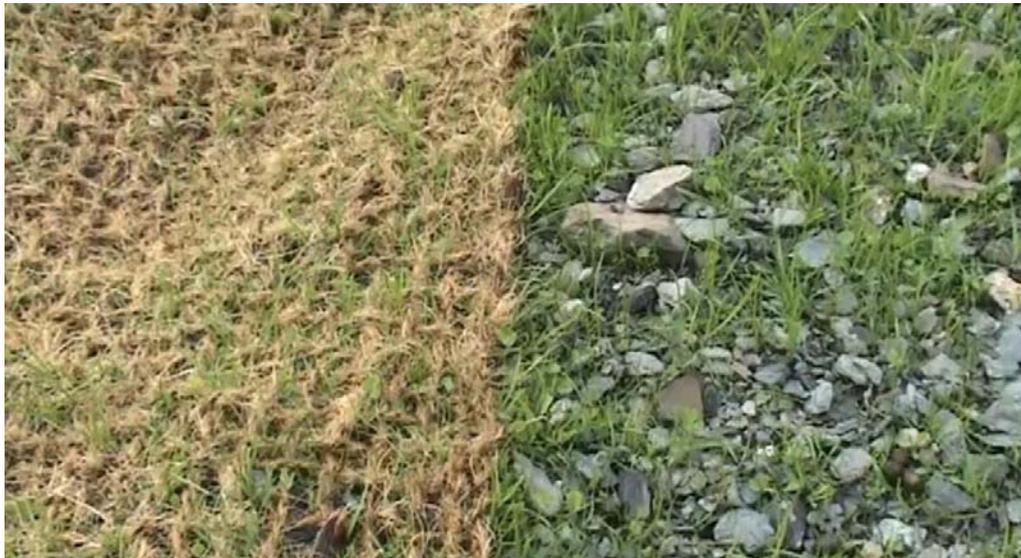
Fig. 7. Results of hydroseeding after about 2 months [1].

From the observed variants of combinations of effects of selected auxiliary soil substances, a variant under the number 4 was selected with regard to results obtained. In this variant, Agrosil LR at a rate of 150g.m^{-2} , a long-term fertiliser Floranid Permanent at a rate of 30g.m^{-2} and bioalginate B.A.S – 90 at a rate of 22.2 ml.m^{-2} were applied. [1]

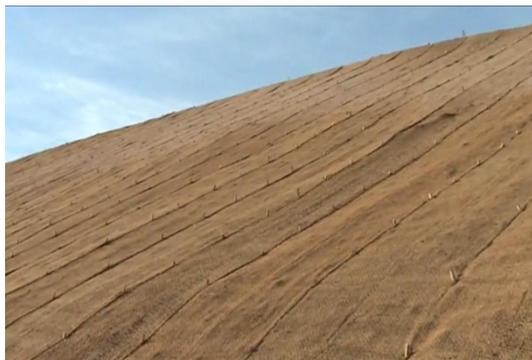
Fig. 8. Coconut mats [1].

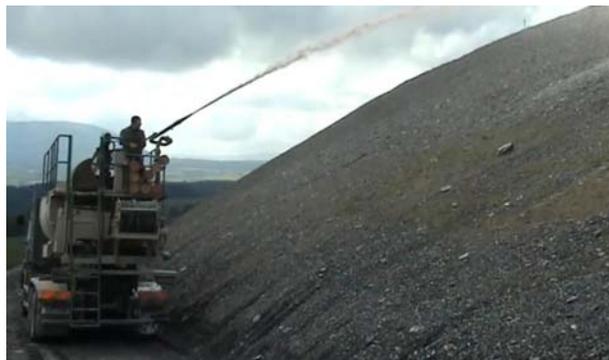
Fig. 9. Equipment – Hydroseeder [1].

Equipment used for spraying the mixture was supplied from the U.S.A. under the name FINN HYDROSEEDER; it is mounted as detachable superstructure on a truck chassis. The hydroseeder has a tank and an agitator assembly that mixes perfectly all components, a pump for required pressure generation and a working platform with a monitor. The volume of the tank is dimensioned at 6600 l of mixture and with one fill, about 2000-3000 m² of the area can be sprayed. The range of spraying of 60 m enables application in inaccessible places; for larger distances, hoses are available. [3]

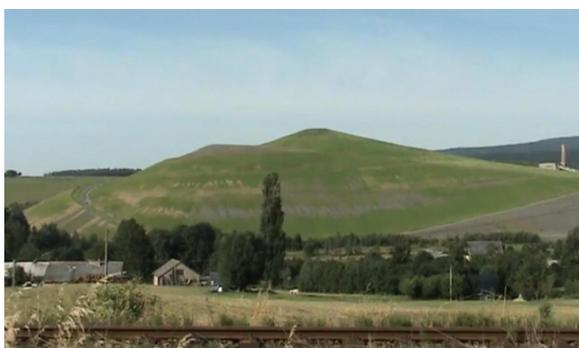
Fig. 10. Central Heap after grassing, July 2009 [1].

At present, rehabilitation work is finished on 11 of 18 hectares of the area concerned. What remains to be done is the part of the heap that is situated on the south side of the heap; grass seeding will continue this year. In future, another utilization of the heap is considered, e.g. the construction of summer sports ground or a ski lift and a piste.

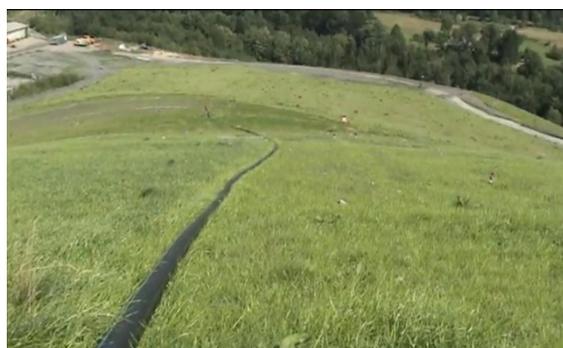
Fig. 11. A view from the top of grassed Central Heap, July 2009 [1].
